## Neighbourhood Plan

## Heritage Assets Evidence Base Document v3

## Eye and Dunsden Neighbourhood Development Plan

### Heritage Assets Evidence Base Document (v3.0)

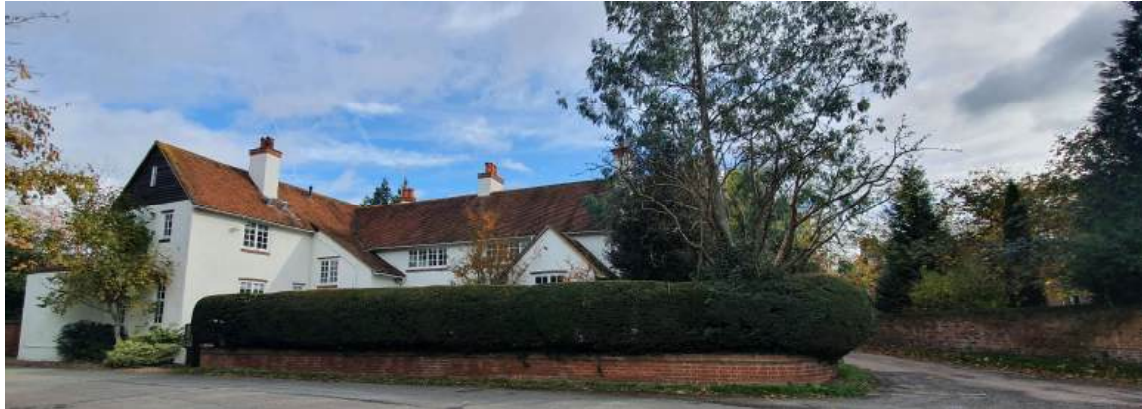
Photos:

"House. 1902, by Halsey Ricardo, for Reginald Blunt, general manager of De Morgan Pottery. Pebbledash brick. Clay plain tile roof with gabled and hipped ends, one gable end weatherboarded; shaped rafter ends exposed under deep eaves. Pebbledash axial and gable end stacks with brick caps and clay pots. STYLE: Domestic Revival. PLAN: L-shaped on plan with service wing on left [N] and entrance porch in the angle. EXTERIOR: 2 storeys. Asymmetrical elevations. NW front has small single-storey wing on right and gable-ended service wing projecting on left with lean-to porch in the angle with simple doorway with cambered tile arch and plank door with stained glass light. The casement windows have glazing bars, brick cills and tiled cambered arches or straight heads; tall narrow windows on the NW gable end, wider 2,3 or 4-light windows elsewhere, first floor tucked under the eaves. The SE garden front has two gables, the left jettied out over projecting bay and on right the wing has hipped roof with very deep overhang over bow window; French casement to left with cambered arch and glazed double doors, and with loggia on right corner with coved canopy over panel of William De Morgan tiles depicting a classical scene with sailing ships and townscape behind; the loggia continues at an angle as a pergola with stone columns, at the back of which is a range of brick outhouses facing the kitchen garden. The NE elevation of the service wing has similar windows, first floor right near corner, ground floor left of centre with small terracotta grille with interlacing; porch to right with cambered canopy backing on to outhouse. INTERIOR: Entrance leads into vestibule and thence into cross-passage. Wing on left of entrance contains service rooms and dining room. To right of entrance, passage leads to a small and a large sitting room (with study off). Stair rises above entrance. On 1st floor continuous corridor along front of house gives access to bathroom (above kitchen) and 6 bedrooms. Original joinery throughout, including ledged board

doors with door furniture; picture rails; kitchen dresser and cupboard (re-located); staircase with corniced board dado and rectilinear open-work balustrade; panelled wall cupboards and window seats to 1st-floor corridor. Original chimneypieces, those to principal rooms (including 4 bedrooms and cross-passage) of polished fossil stone with moulded surrounds framing Delft tiles; that in large sitting-room of yellow brick with corbelled stone mantel-piece and over-mantel of William De Morgan tiles. Original bathroom retains tiled floor and walls and original bath."

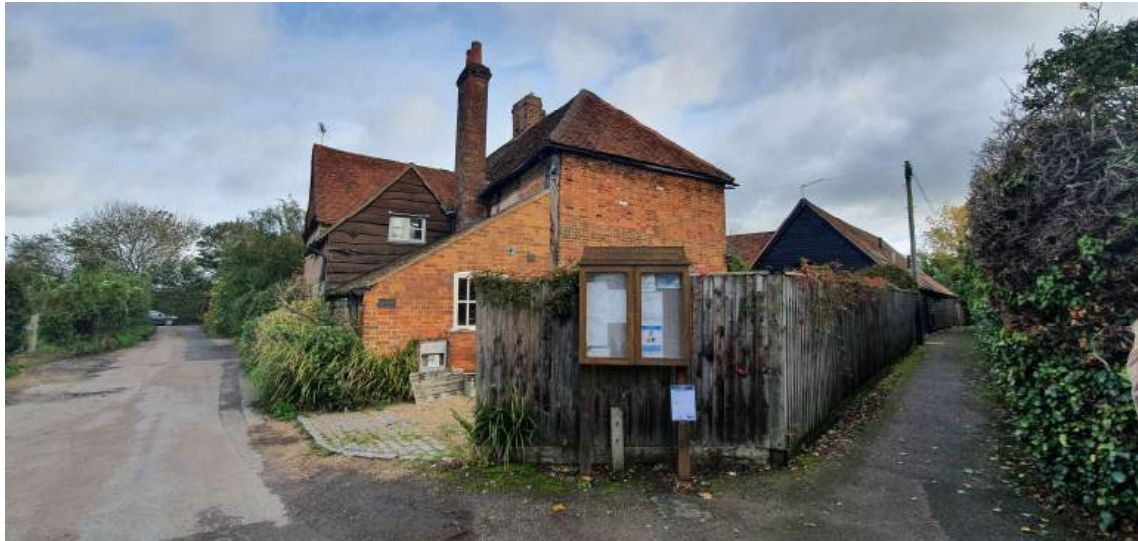
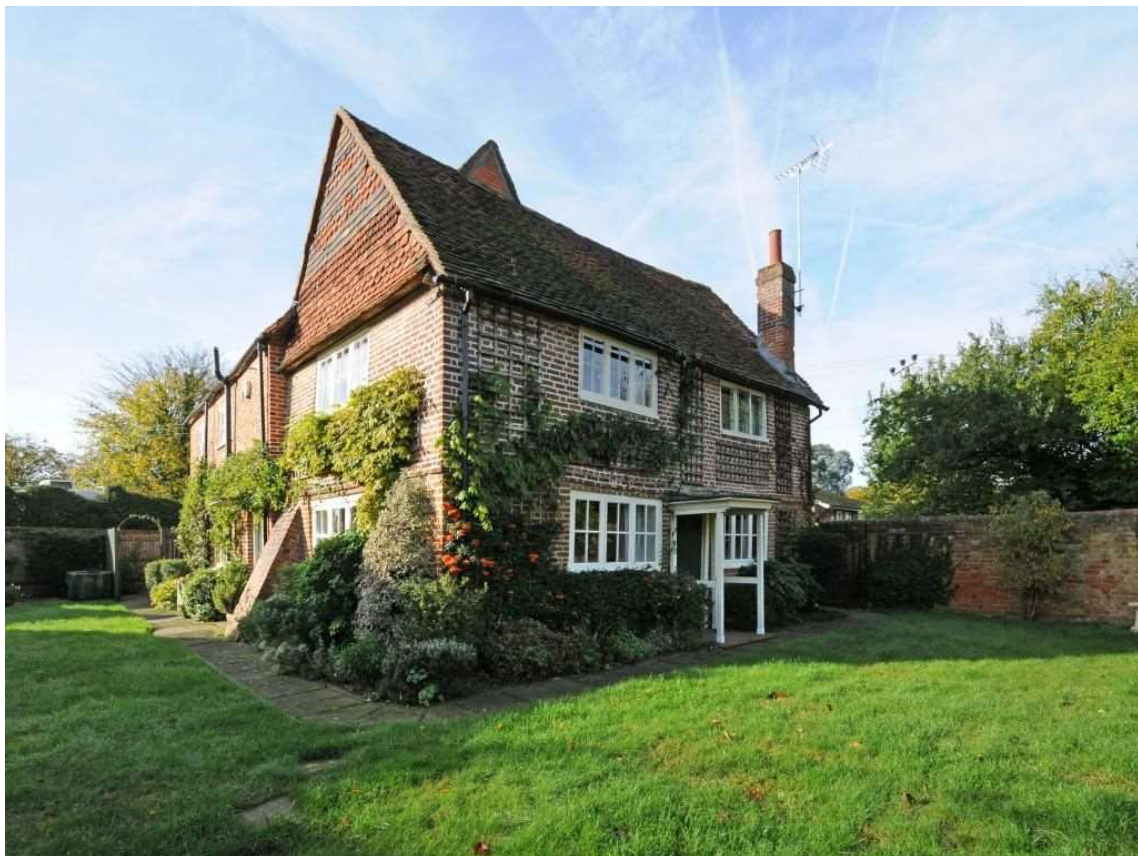
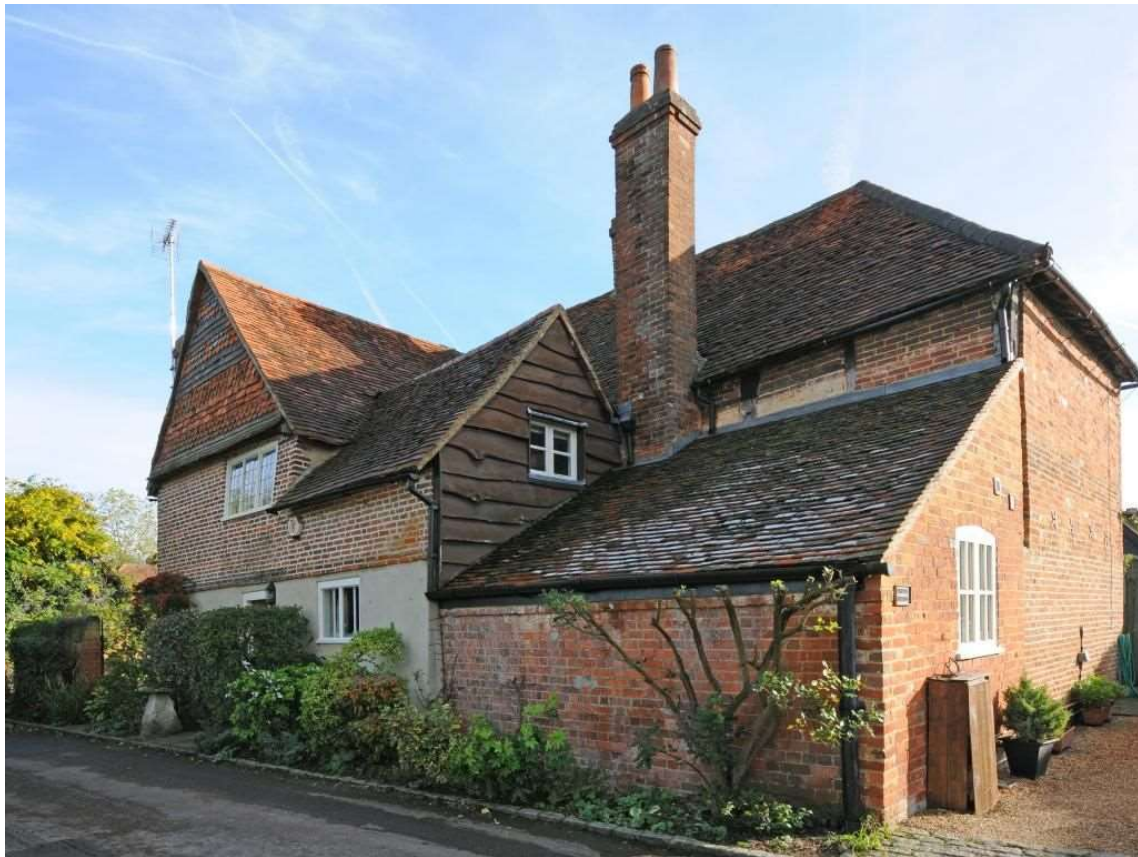
"EYE AND DUNSDEN SONNING EYE SU77NE 10/63 Frizer's Farm House 24/10/51  
(Formerly listed as Grierson's Farmhouse and outbuildings) GV II

Farmhouse. Probably late C17. Red brick; plain tile roof; brick stack. 2-unit plan. 2-storey, 2-window range. Central 6-panel glazed door with lattice porch and flat hood; 3-light casements to all openings except ground floor right sliding sash. Flat brick band between ground and first floor. Internal stack to right. Timber-frame wing to rear. Interior not inspected."

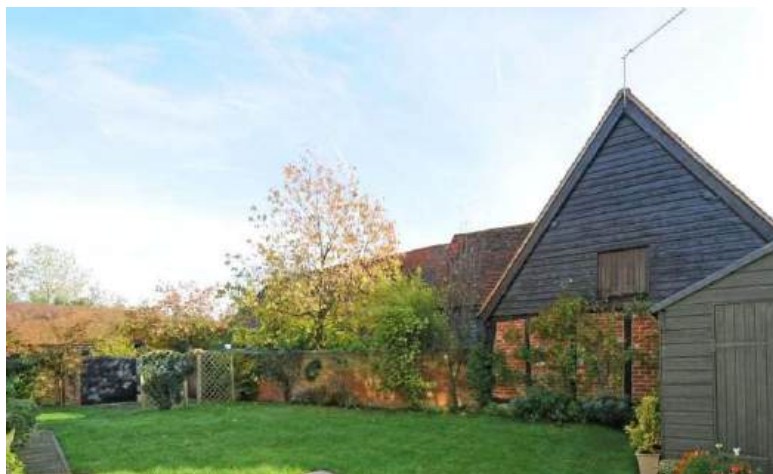
Photos:

"Barn approx 30 metres 24/10/51 south-east of Frizer's Farmhouse (Formerly listed as Grierson's Farmhouse and outbuildings) GV II Barn. Probably early C18. Brick base; large frame timber framing; weather-boarding; plain tile roof. 4-bay barn. Gabled midstre to left of centre. Queen post roof construction."

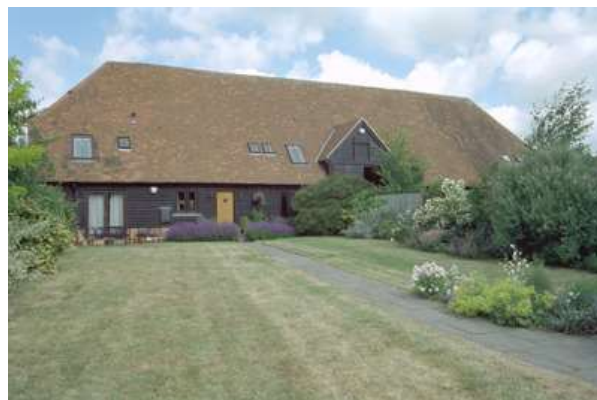
“EYE AND DUNSDEN SONNING EYE SU77NE 10/65 Barn approx 40 metres east 24/10/51 of Frizer's Farmhouse (Formerly listed as Grierson's Farmhouse and outbuildings) GV II

Barn. Probably early C18. Brick base; large frame timber framing; weather-boarding; plain tile roof. 7-bay barn, aisled to both sides. Central midstrey; gabled to east, hipped roof to west on brackets. Plank doors to west, those to east missing. Half-hipped roof. Queen-strut roof construction. C19 wing to north.”

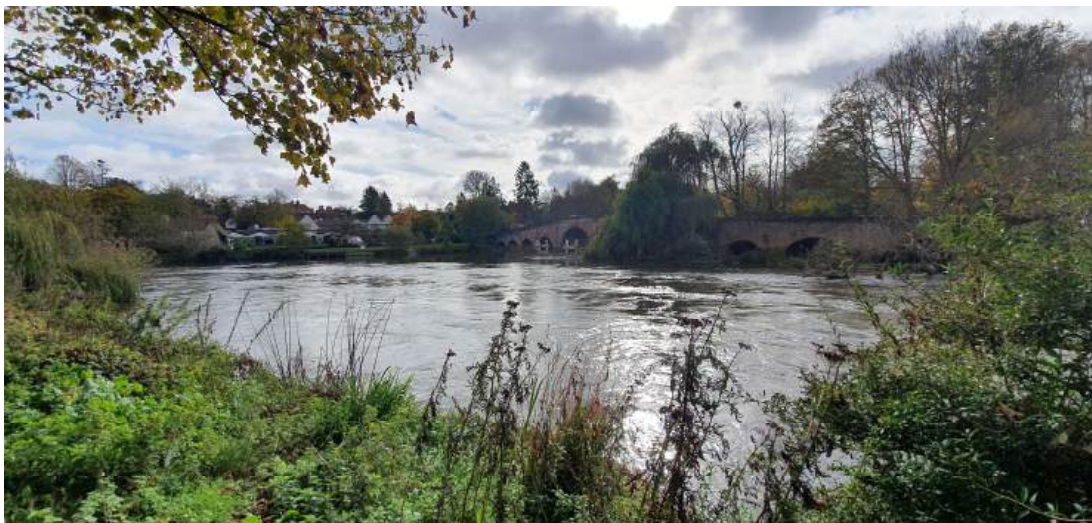
“Road bridge. Built 1780-1790 and sketched in 1792 by Samuel Ireland. Brick, plain parapet. Large arch roughly in centre flanked by flat brick band and pilasters. 4 lower arches divided by cut-waters on the Oxfordshire side. 4 similar arches on Berkshire side. B.O.E.Berkshire p.220. V.C.H. Vol.111.p.210.”

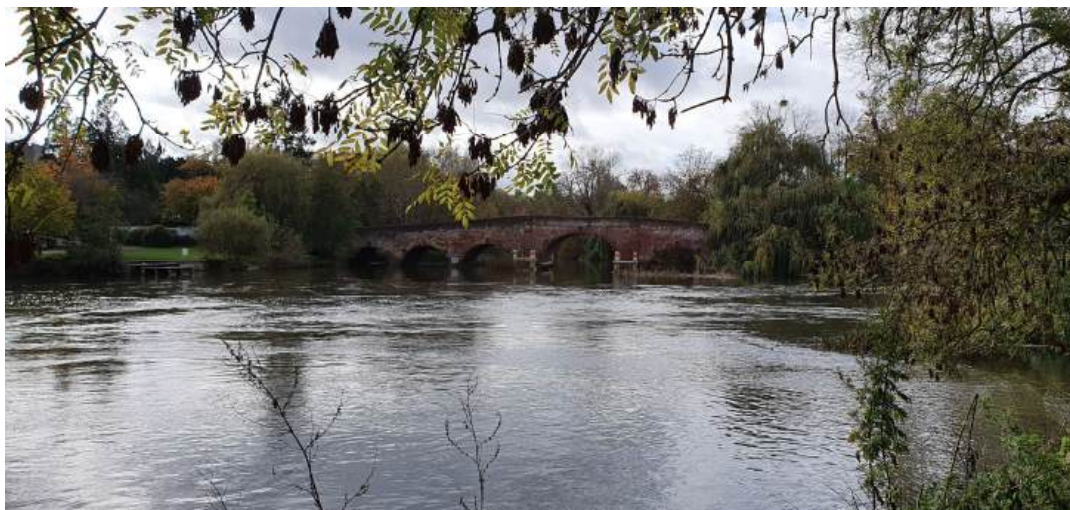
“Bridge across River Thames approx 120 metres east of Sonning Mill GV II Road bridge. Built 1780-1790 and sketched in 1792 by Samuel Ireland. Brick, pla parapet. Large arch roughly in centre flanked by flat brick band and pilasters. 4 lower arches divided by cutwaters on the Oxfordshire side. 4 similar arches on the Berkshire side. (Buildings of England; Berkshire, p. 220: V.C.H. Berkshire III, p. 210)”

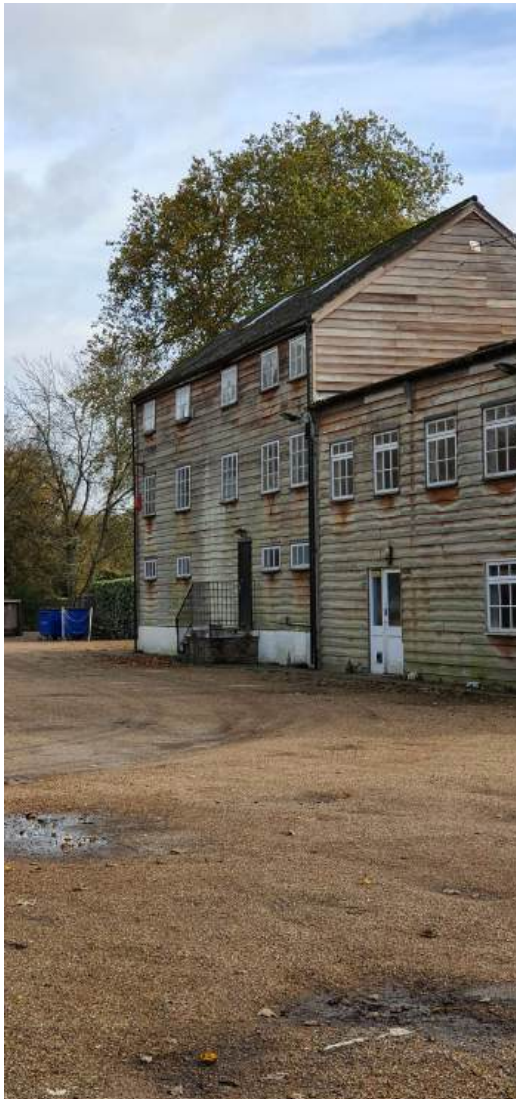
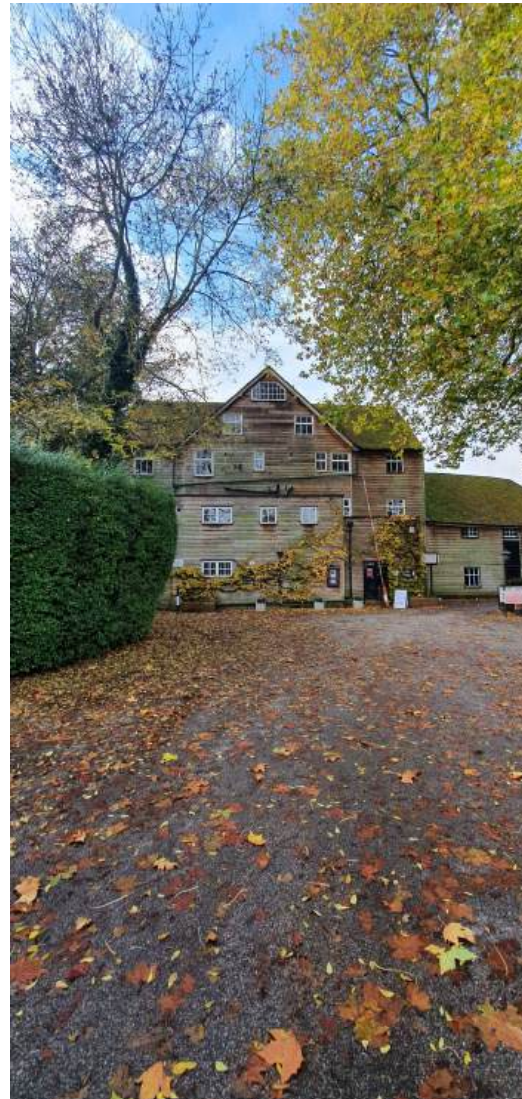
"Mill, now theatre. Early C19 with late C20 alterations. Timber framed and weatherboarded; plain-tile and slate roofs. Complex plan. 4 storeys with 2 attic storeys; 5-window range. Projecting 2-storey wing to front with irregular C20 fenestration. Main entrance to side of wing. C20 glazed doors. C20 casements, irregular fenestration to main block. 2-storey cross-gable to attic with casement windows. Interior: altered late C20 for theatre but original mill structure survives to front building."

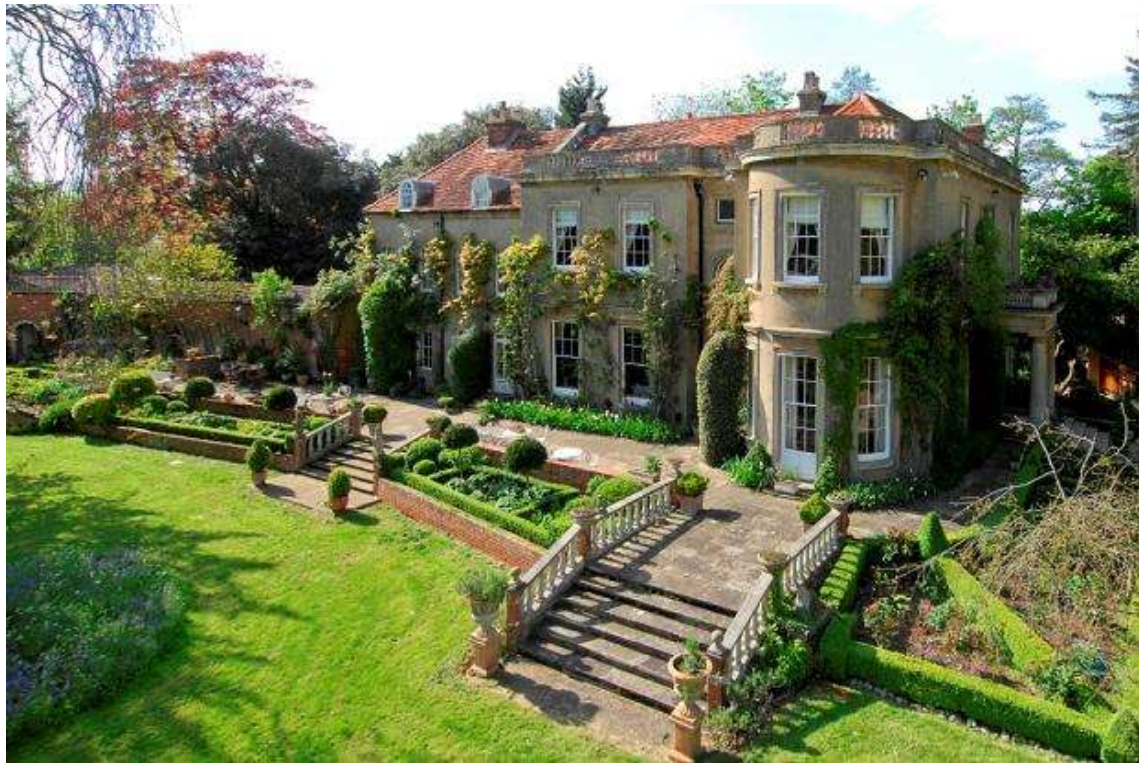
"EYE AND DUNSDEN SONNING EYE SU77NE 10/70 Mill House GV II House, wrongly shown on O.S. map as Aberlash House. Probably early C19 front to late C18 house. Bath stone ashlar; plain tile roof; brick stacks. 2-storey, 3-window range. Central 6-panel door with side and over-light. Square-plan porch of paired Roman Doric columns, which support balcony with pierced stone balustrade. 12-pane sashes to each side, with moulded stone surrounds with triangular pediments on brackets above. Three 12-pane sashes to first floor, with moulded stone surrounds with brackets to sills. Balustrade to roof. Half-circular bow window to left-hand return. Interior not inspected but likely to be of interest."

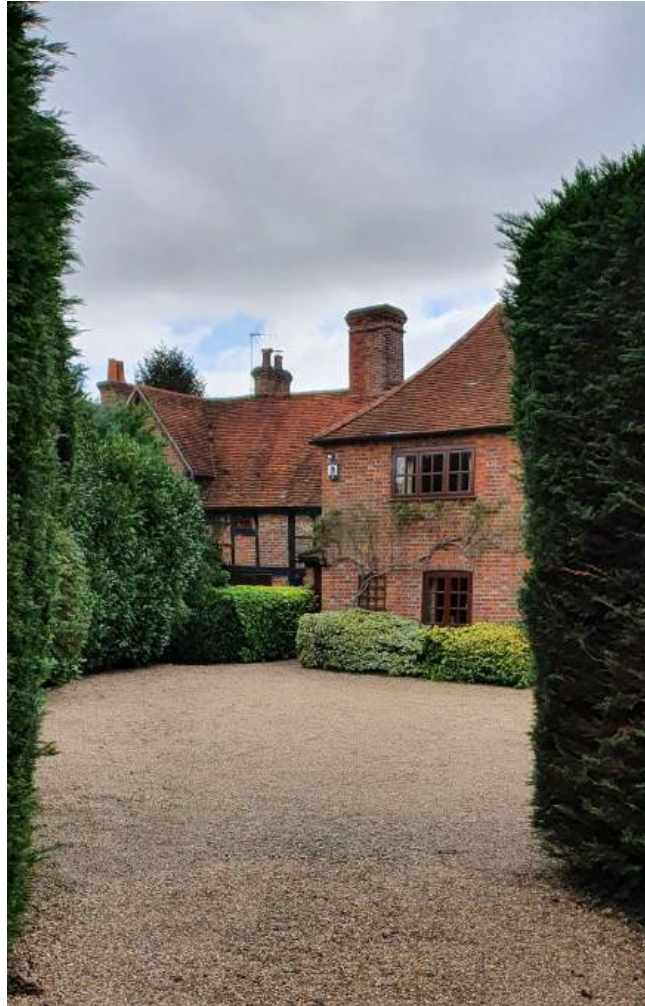
"Farmhouse and attached cottage. C17 with C19 extensions and C20 alterations. Irregular timber framing to-centre, brick infill, brick to left and right; plain tile roof; brick

stacks. L-shaped plan. 2-storey, 5-window range. C20 glazed porch to right with plank door. Stable door to left. Irregular fenestration, casements. 2 cross-gables to right, possibly C19. Hipped roof projecting C19 wing to right, red brick with grey headers, 2-storey. Central ridge stack and end stacks to left and right. Interior not inspected.”

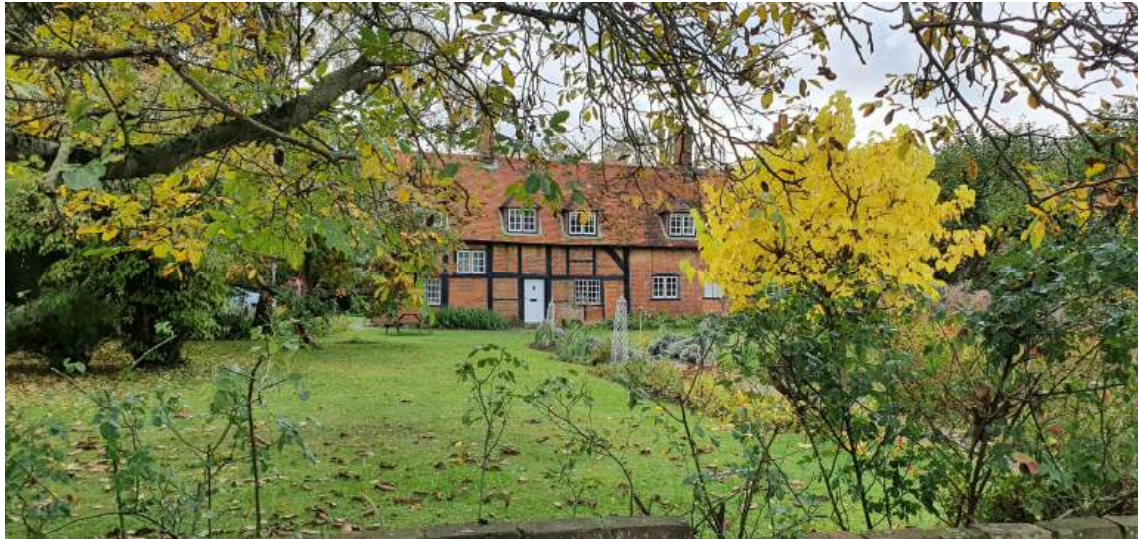
"EYE AND DUNSDEN SONNING EYE SU77NE 10/68 Long Gardens - II

Row of cottages, now house. Probably late C17 with C19 extension to right. Timber frame with brick infill; plain tile roof; brick stacks. One storey and attic; 6-window range. Plank door to left of centre. Irregular fenestration of 6 casements to ground floor. 5 hipped dormers. Ridge stacks and end stack to right. Interior not inspected."

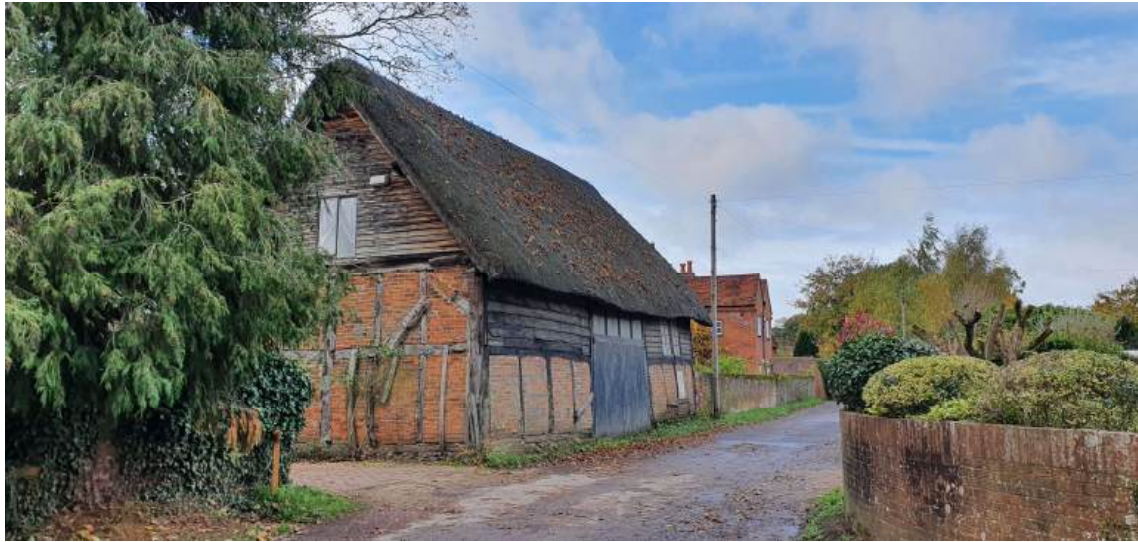
"Barn. Probably C18. Timber-framed with thatched roof. Many of the timber-framed panels infilled with brick. PLAN: Rectangular, three-bay, with projecting cart bay to south and opposing double doors (flush with north wall) opening on to street. Pitched thatch roof with half-hip to east end. Simple box framing with centre rail, all of fairly light scantling. Upper portion of barn walls and cart bay retain weather boarding, while most of lower panels of timber framing infilled with brick. Various casement windows inserted on north side, and to east and west gables. Small later lean-to against east side of cart bay. INTERIOR: Largely original roof with collar and tie-beam trusses, albeit with some replacement of timbers especially at junction with cart bay. Purlins supporting common rafters with broad spars to support thatch all largely original. Centre and west bays open and used for general storage; east bay divided off with fairly crude later C20 studding and with inserted stair and first floor. HISTORY: The barn supposedly once formed a part of the Mill House farm complex. It was presumably for the storage and processing of cereal crops, although its capacity will have been very limited and the farmyard may also have been included far larger barns."

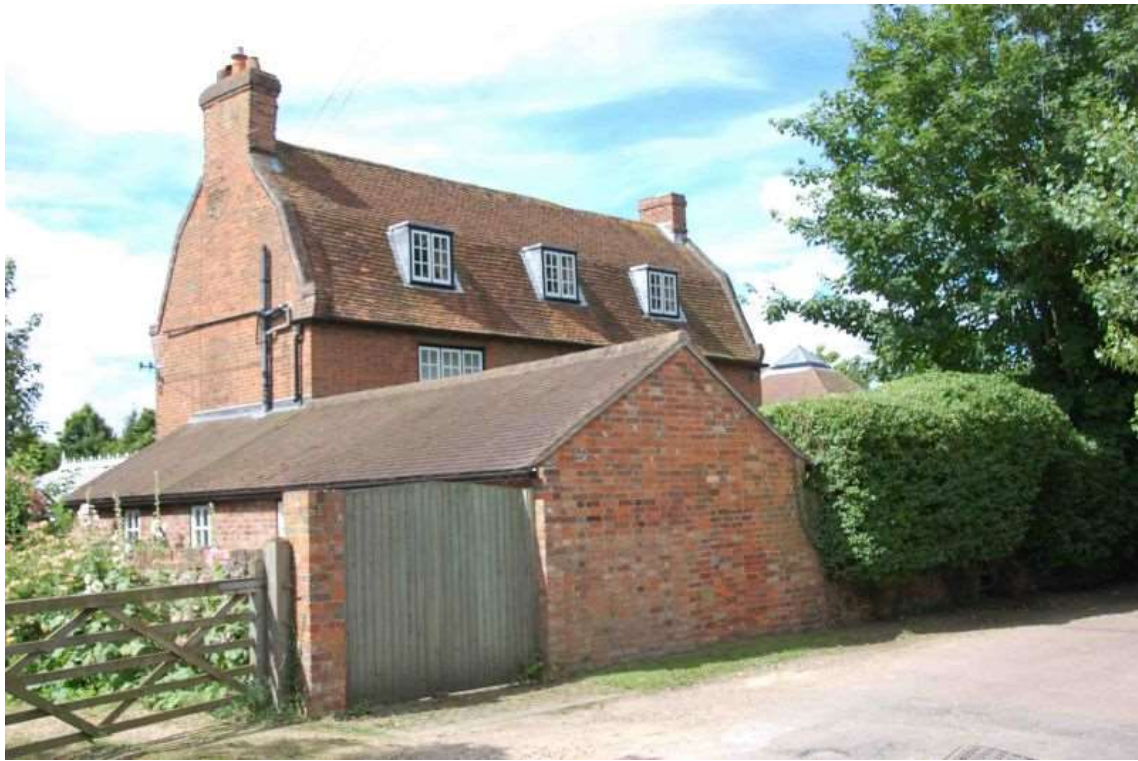
“EYE AND DUNSDEN SONNING EYE SU77NE 10/66 24/10/51 The Homestead - II Farmhouse, now house. C17 to rear with probably mid C18 front. Red brick with grey headers; plain tile roof; brick end stacks. 2-unit plan. 2 storeys and attic; 3 window range. Central 6-panel part glazed door. Casements to all openings. Gambrel roof with three 2-light full dormers. Interior: C17 stop-chamfered spine beam and joists to kitchen at rear. straight flight stair with winder.”

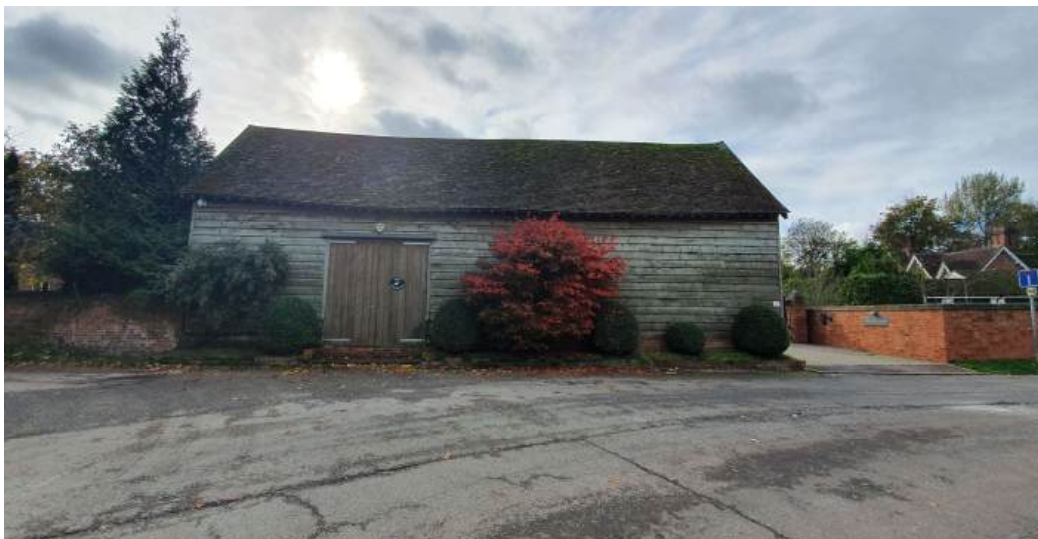
"Barn approx. 60 metres west of The Homestead - II Barn. Probably early C18. Brick base; timber-frame with brick infill and weather-boarding. Plain tile roof. 5-bay barn. Entrance to left of centre. Gabled midstrey, probably C19, to rear. Queen-post roof with some windbraces."

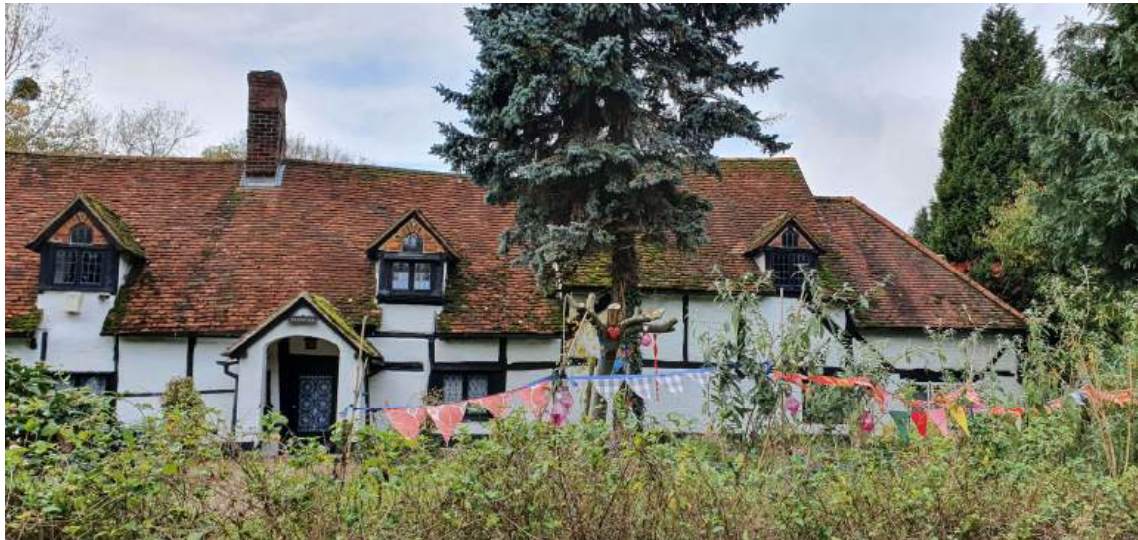
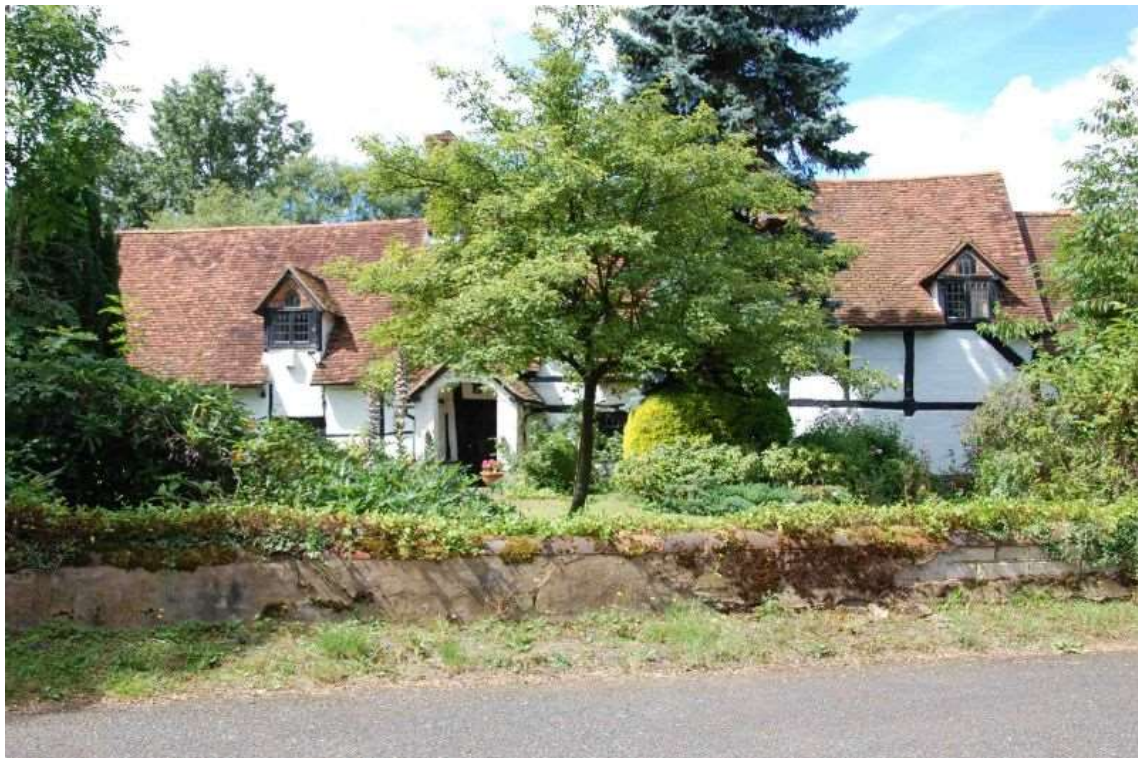
"House. C18 with C19 alterations. Irregular timber-frame with painted brick infill; plain tile roof; brick ridge stacks. Gabled porch to left of centre with glazed C20 door. Three C19 metal casements. 3 dormers, with C19 gothic casements."

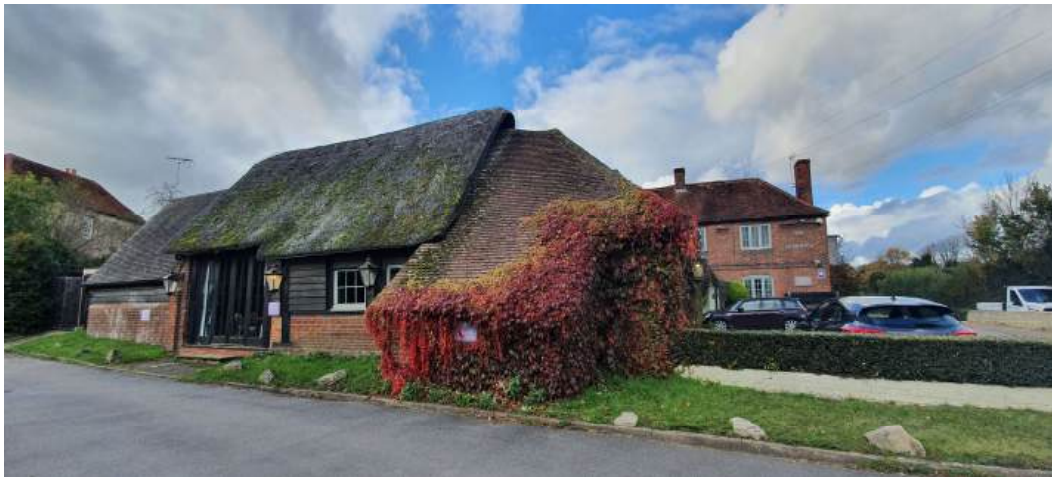
Photos:

"Public House. Possibly C16 with C18, C19 and C20 alterations. Red brick with flared headers; timber frame wing with brick infill to left; plain old tile roof; brick stacks. Probably originally lobby-entry plan. 2 storey, 2-window range with lower 2 storey wing projecting to left. Central C20 timber-frame porch with C20 sash door; gabled tiled roof, 3-light C19 casement to right, 2-light C19 casement above porch and 3-light C19 casement to right first floor. Irregular C19 fenestration of casements to left return of wing. Hipped roof to range with ridge stack to left of centre and end stack to right. Queen-post truss visible to gable end of wing. Interior: Chamfered beams with end stops survive. Subsidiary feature C19 single storey brick wing projects to left with 2-bay barn, possibly C18, weather boarded and thatched to end."

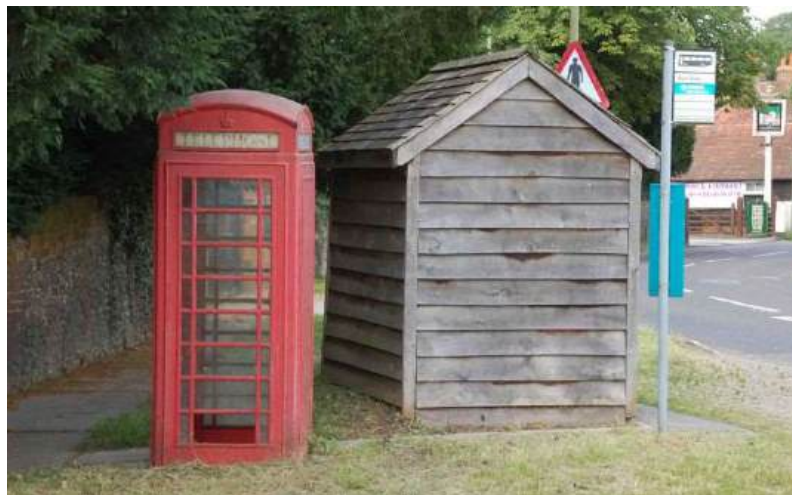
Photos:

"Telephone kiosk, type K6. Designed 1935 by Sir Giles Gilbert Scott. Made by various contractors. Cast iron. Square kiosk with domed roof. Unperforated crowns to top panels and margin glazing to windows and door."

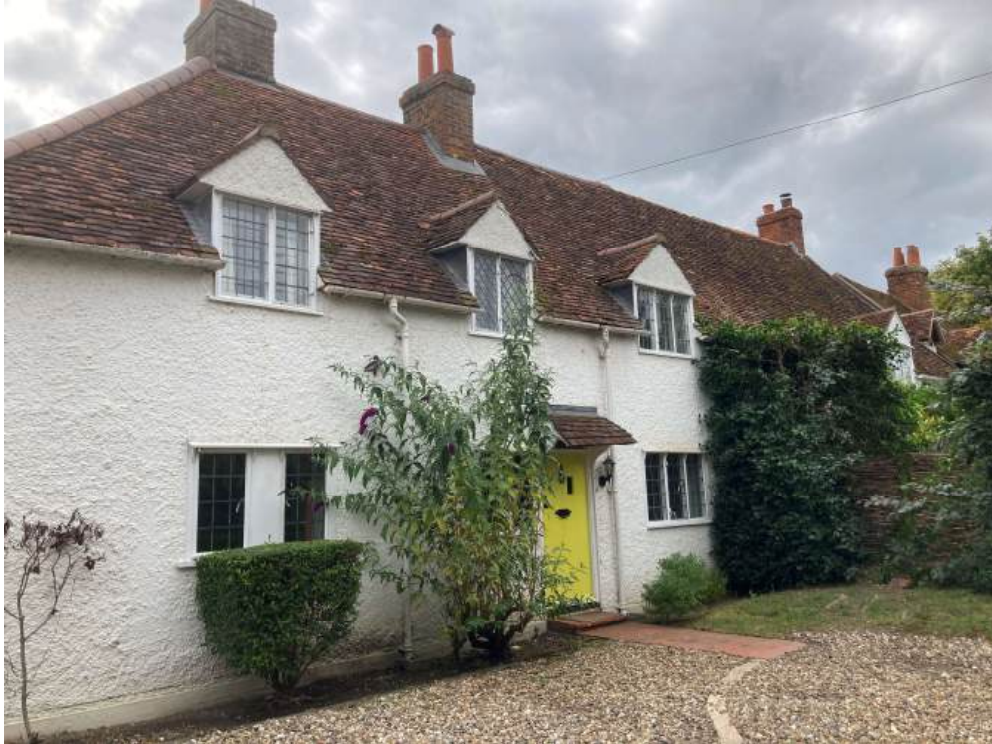
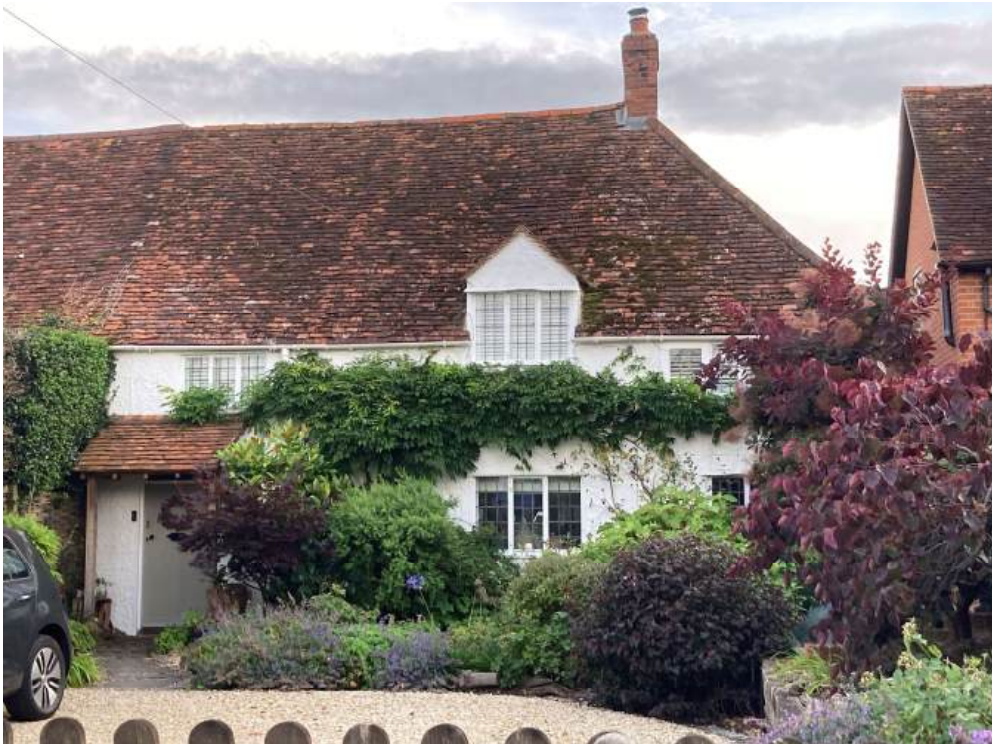
"House, now 2 cottages. Probably C17. Roughcast probably on brick; plain tile roof; brick stacks. One storey and attic to left, 2 storey to right. 6-window range. Plank doors to left and right of centre. Irregular fenestration of 5 casements to ground floor. 3 gabled half

dormers to left, 1 gabled half-dormer to right with 2 casements. Hipped roof. Ridge stacks. Interior not inspected.”

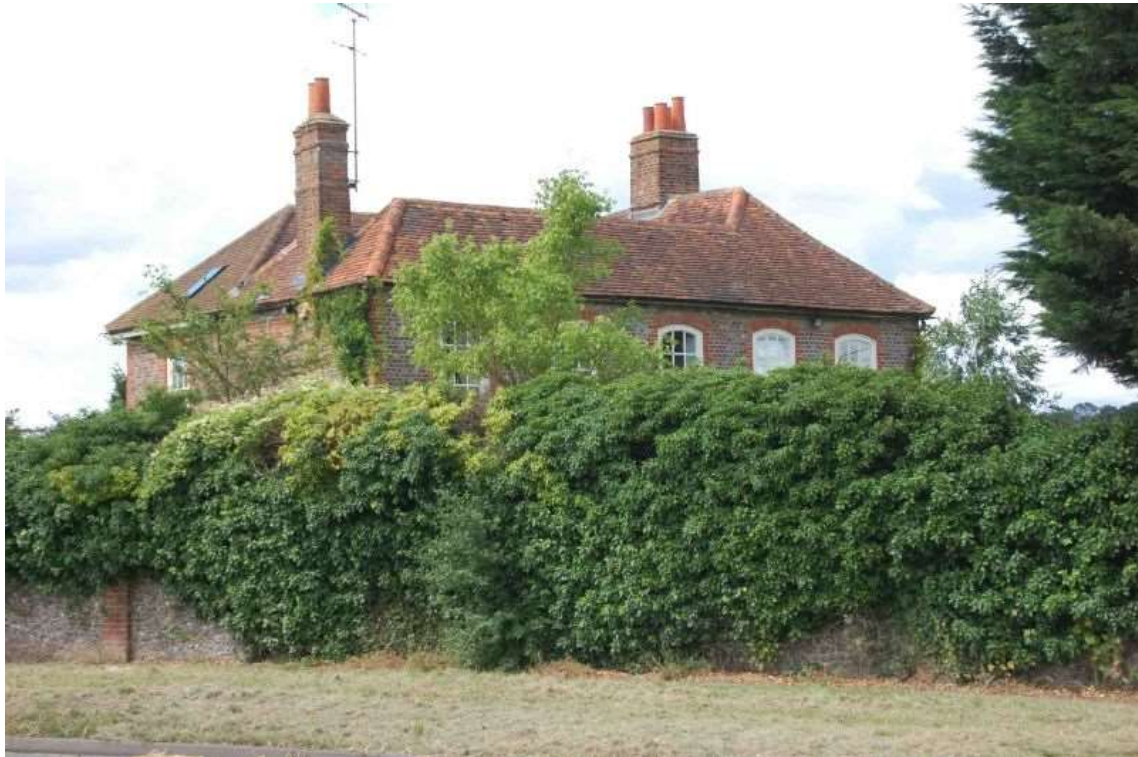
"EYE AND DUNSDEN PLAYHATCH SU77NW 9/59 Playhatch House 24/10/51 - II House. Early C18. Grey brick with red dressings and plain tile roof; brick stack. 2-unit

plan. 2-storey, 5-window range. Central 6-panel part glazed door with flat hood on brackets. 12-pane segmental topped sashes with thick glazing bars to all openings. Rubbed brick arches to windows, brick band between ground and first floor. Hipped roof, with brick stack to left end. Single-storey wing to right. Interior not inspected."

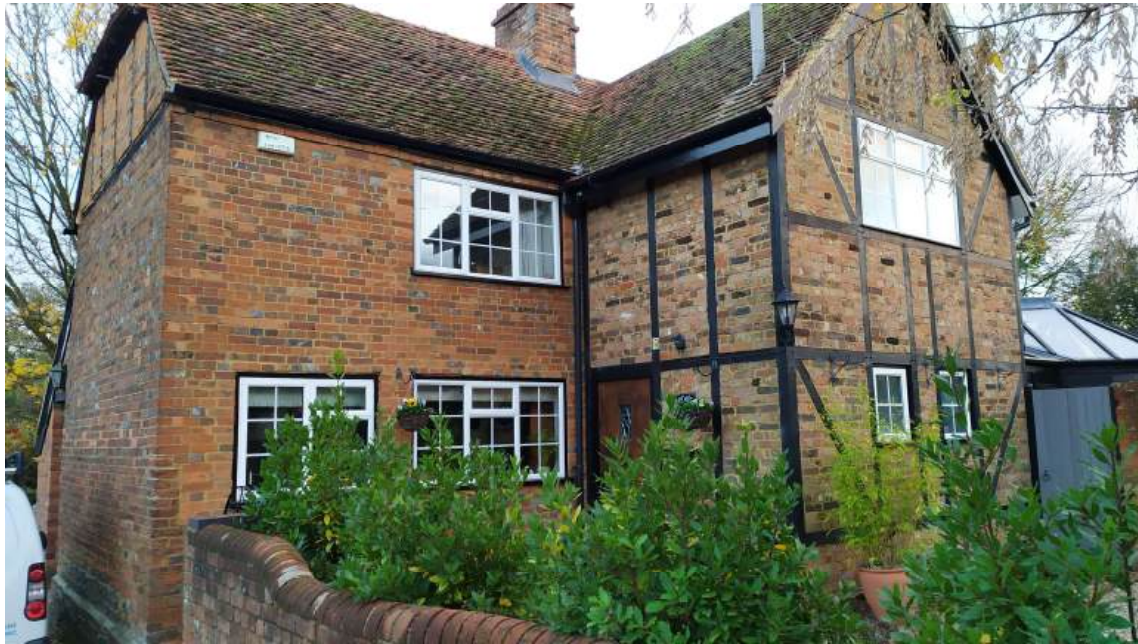
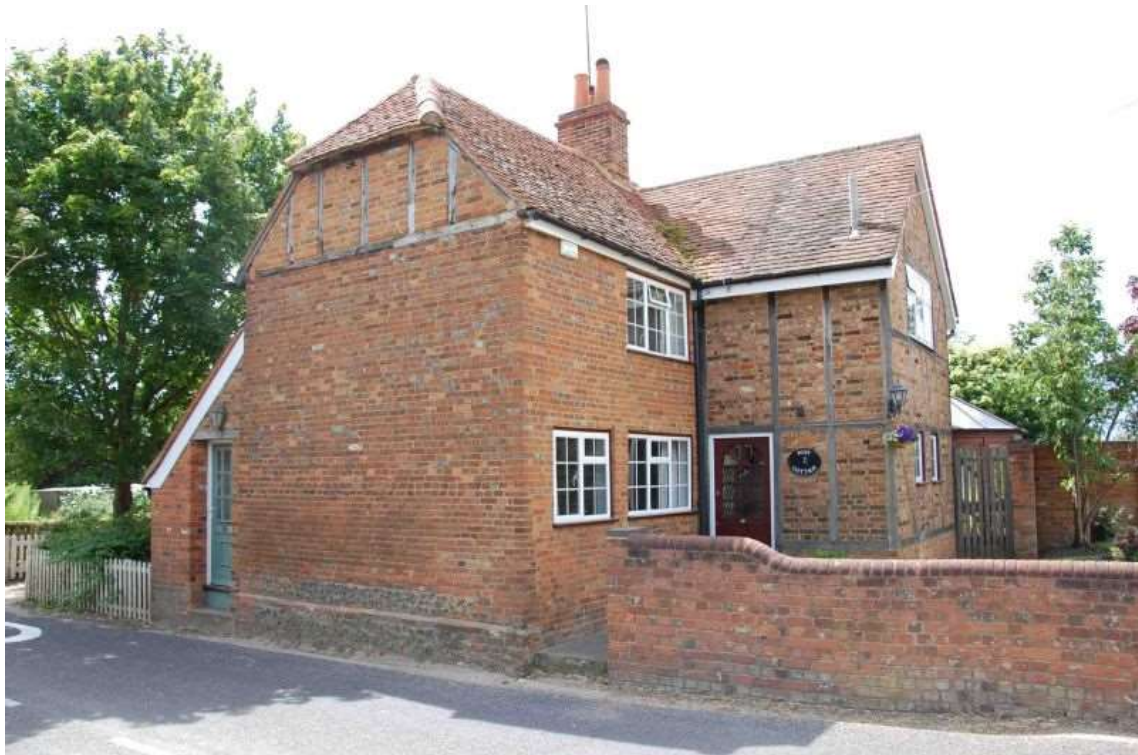
"Cottage. C18 with C20 additions and alterations. Large timber framing with brick infill; brick to right hand return; plain tile roof; brick centre ridge stack. Probably lobby entry

plan. Main front to south. Timber framing to ground floor under lean-to roof with sloping C20 roof lights. Timber framing to first floor. Right return to road. C20 sash door to left. Rear C20 cross- gabled timber frame 2-storey extension. Irregular fenestration of C20 windows. Occupies a prominent position with its main front at right angles to street. Included for group value."

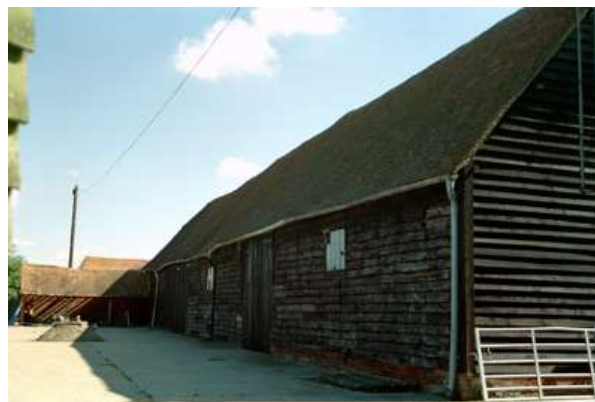
"EYE AND DUNSDEN SU77NW 9/45 Bishopsland Farmhouse, barn 24/10/51 approx 60 metres south-west (Formerly listed as Bishopsland Farmhouse and outbuildings) GV II Barn. Probably early C18. Brick base; large timber framing; weatherboarded; plain tile roof. 9-bay barn with aisle to east. 2 gabled midstreys to east with plank doors. Half hipped roof. Queen-post roof with wind braces. C19 wing to east."

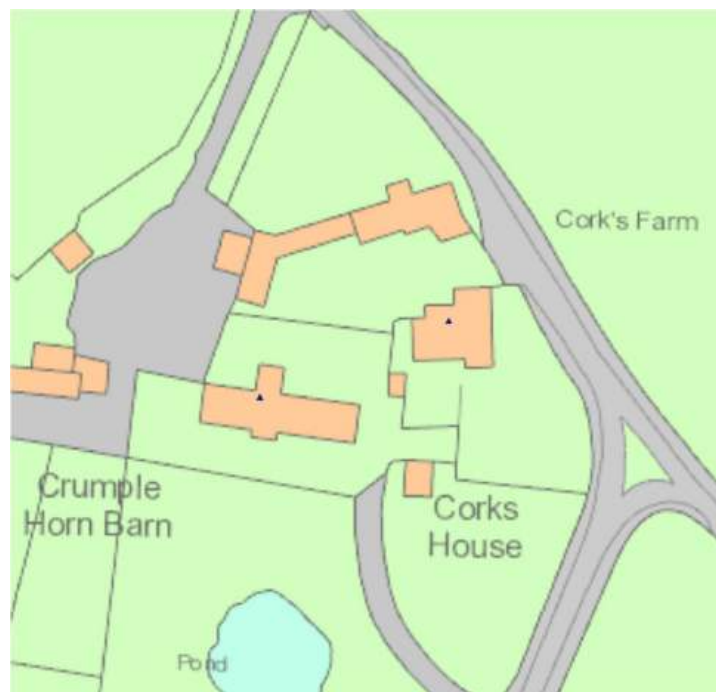
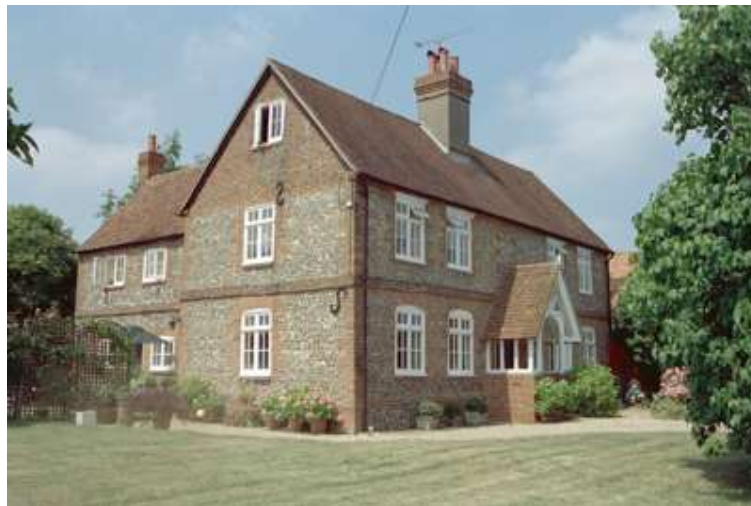
"Farmhouse. Probably early C18 with C19 porch. Flint with brick quoins and dressings; plain tile roof; rendered brick stack. Lobby-entry plan. 2-storey, 5-window range. Central 4-panelled part glazed door with C19 gabled porch. Wood mullion and transom windows to all openings, blind openings to centre first floor. Flat brick band between ground and first floor. Central ridge stack. Interior not inspected."

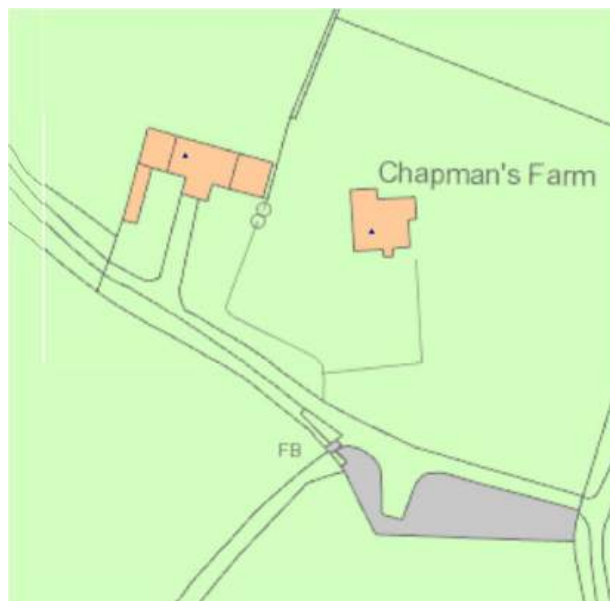
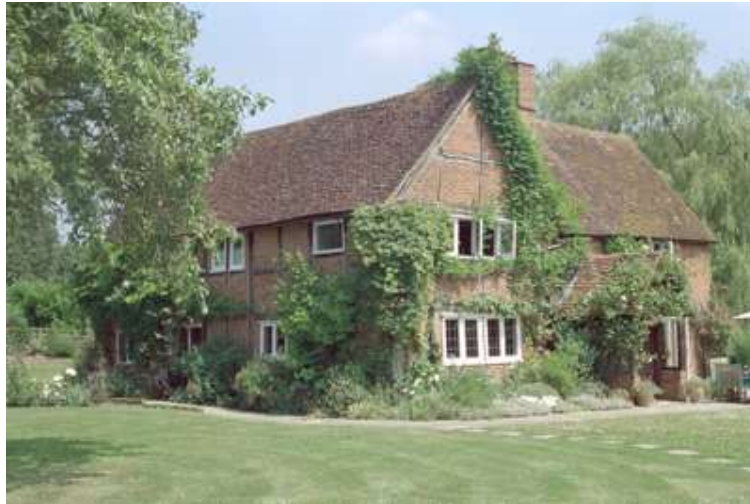
"EYE AND DUNSDEN DUNSDEN GREEN SU77NW 9/54 Chapmans Farmhouse 24/10/51 (Formerly listed as Chapmans Farmhouse and outbuildings) GV II Farmhouse, now house. Possibly late C16, with C19 and C20 additions. Timber frame; brick infill; plain tile roof; brick ridge stack. L-shaped plan. 2-storey, 2-window range. Central C20

gabled porch with double 2-panel oak doors. French door to right, 4-light casements to left, 3-light casement to 1st floor right. Cross-gable to left. Central ridge stack. Timber frame visible to left-hand return. Interior not inspected.”

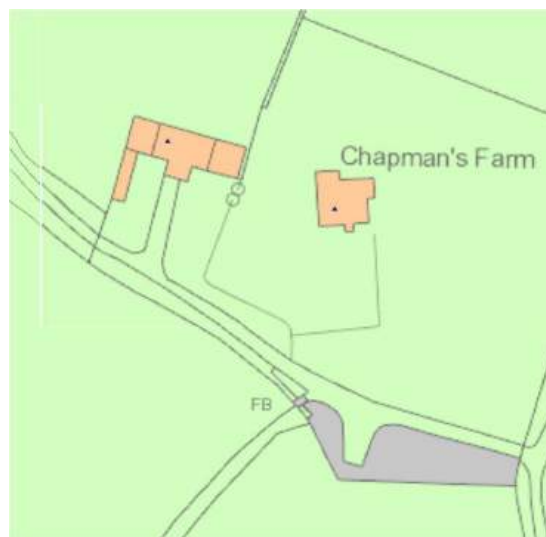
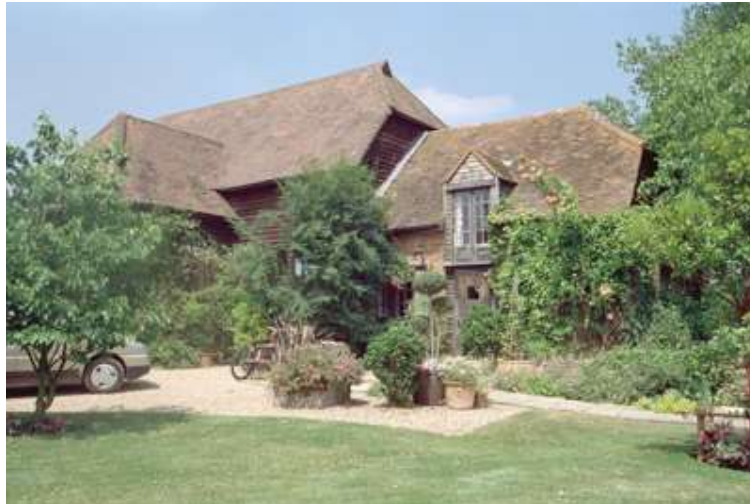
"EYE AND DUNSDEN DUNSDEN GREEN SU77NW 9/55 Barn approx 30 metres west 24/10/51 of Chapman's Farmhouse (Formerly listed as Chapmans Farmhouse and outbuildings) GV II Barn. Mid C18. Brick base; timber frame, weatherboarding, plain tile roof, 3-bay barn. Central midstrey to south with double-plank doors and projecting hipped roof on brackets. Half-hipped roof. Interior: Queen post roof construction. Subsidiary feature: C19 single-storey L-plan wing to west."
