## Neighbourhood Plan

## Heritage Assets Evidence Base Document v3

## Eye and Dunsden Neighbourhood Development Plan

### Heritage Assets Evidence Base Document (v3.0)

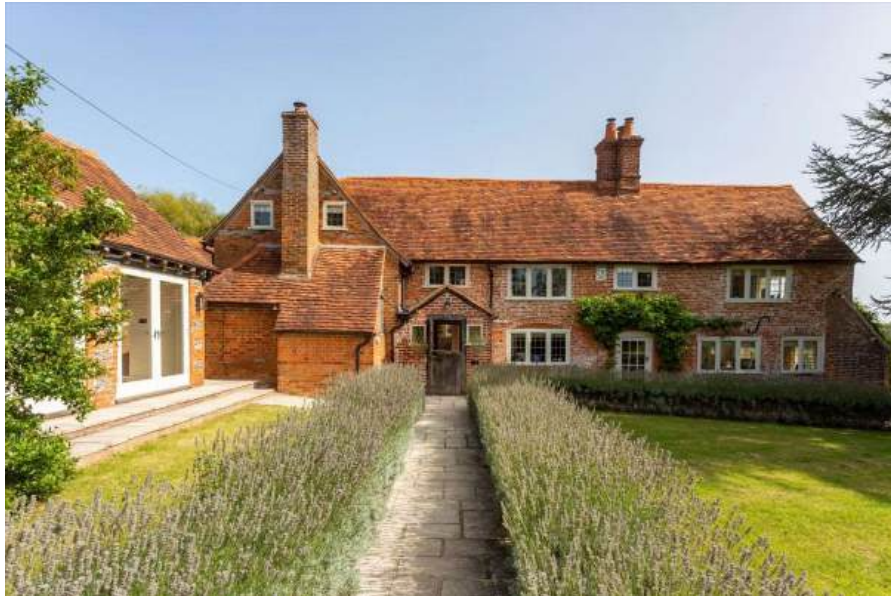
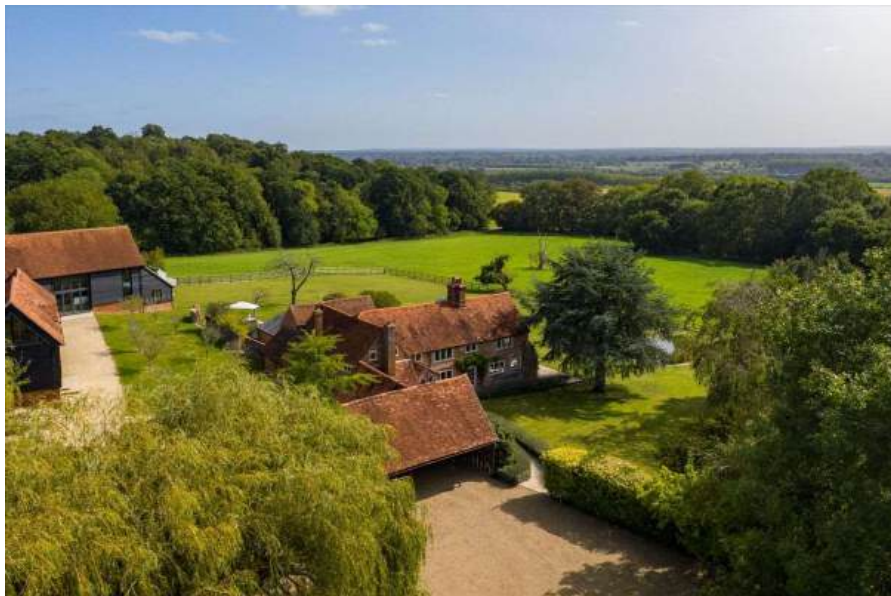
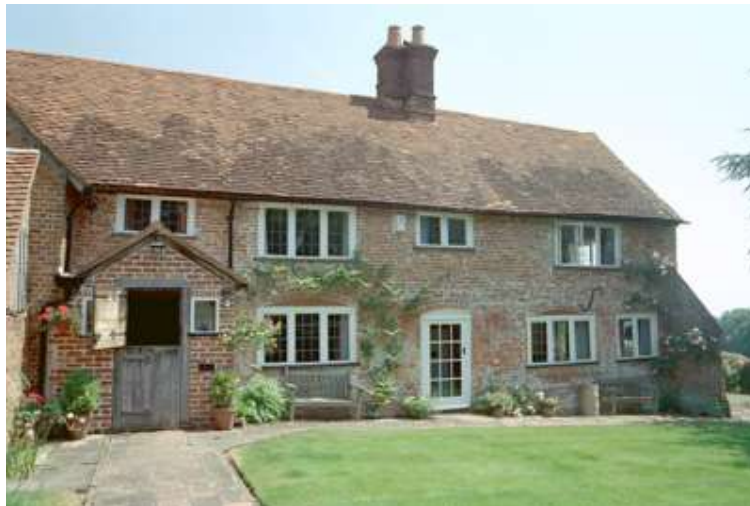
"House. Probably late Medieval, but largely rebuilt in the C17. Red brick in mainly random bond, platband at rear; timber-framed cross-wing largely rebuilt in brick. Clay plain tile roof with gabled ends. Brick axial and gable-end stacks. PLAN: The cross-wing, at the left [NW] end, is all that survives of a Medieval house, the hall of which has been demolished. The main brick range is of 3-room plan with an axial stack between the centre and right hand rooms [probably originally with a lobby entrance] and a small inner room on the left [now an entrance and stair hall with a porch at the front in the angle with the cross-wing]. The cross-wing has a stack and ovens on the front gable-end and it has been extended at the rear in the late C20. EXTERIOR: 2 storeys. Asymmetrical 4-window main range with cross-wing on left with single-storey lean-to on front and C20 gabled porch in the angle. C20 1, 2 and 3-light casements, those on ground floor in widened cambered arch openings. C20 glazed door to right of centre. Large brick diagonal raking buttresses on lower right hand end. At rear circa C18 2-light casements on first floor with leaded panes, extended gable-end of cross-wing on right with C20 porch in the angle. INTERIOR: Larger right hand room has chamfered axial beam with ogee stops at one end, exposed joists and large brick fireplace with chamfered timber lintel with straight-cut stops. Smaller central room has chamfered axial beam with hollow step stops and large rebuilt brick fireplace with long hollow step stops. Timber-framed wall between centre and small left room [now hall] which also has chamfered axial beam. Cross-wing has large chamfered cross beam with straight-cut stops, one beam replaced and some remaining broad joists; fireplace largely rebuilt. Roof: The main range has an intact C17 queen-post and clasped purlin roof structure with curved wind-braces; common rafter couples, some of which are smoke-blackened and re-used from former open hall. The cross-wing was re-roofed in the C17 with side purlins and common rafter couples."

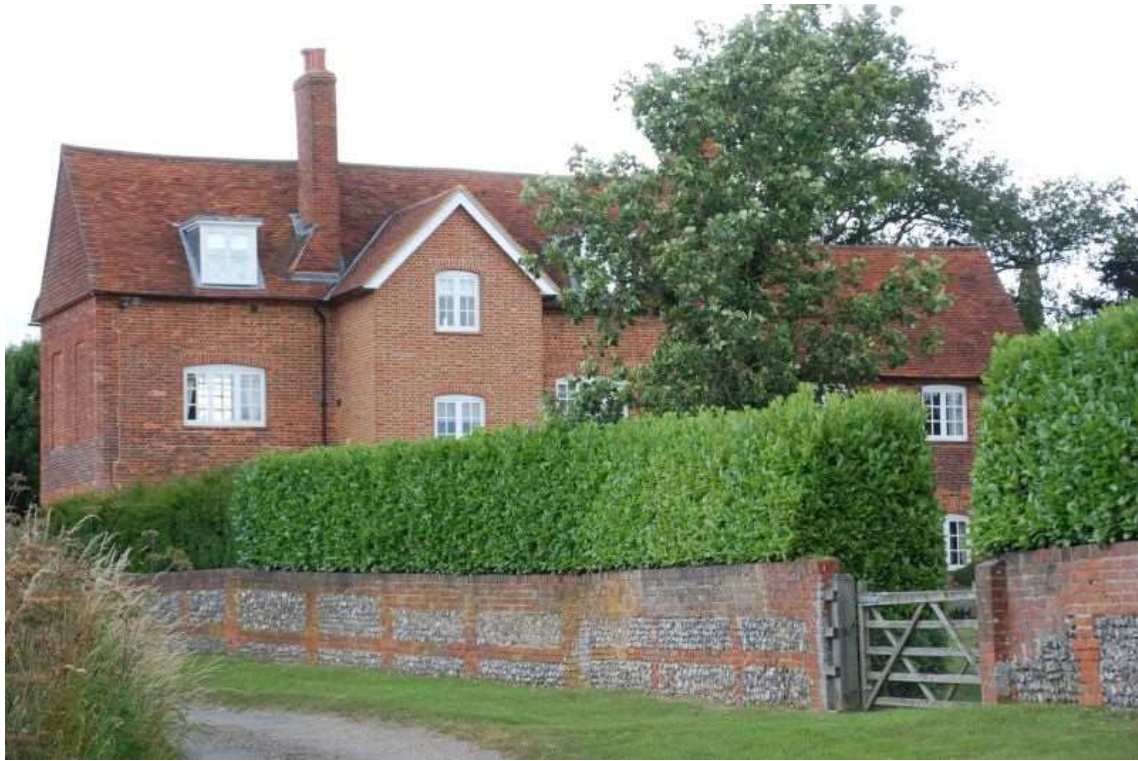
"Farmhouse, now house. Late C17 with C19 additions. Flared brick with red brick dressings; rubbed brick aprons and flat arches to windows. Plain tile roof. Garden facade, former entrance front: 2-storeys plus attic, 5-window range. Central bay projects forward approx 30 cms. Central sash door with moulded wood surround with flat hood on decorative brackets. Fluted and reeded Doric pilasters in rubbed brick to ground floor centre bay, unfluted to 1st floor; 24-pane sashes with thick glazing bars to all openings. Rubbed brick band between ground and 1st floor to left and right of central bay. Shaped rubbed brick aprons to 1st floor windows. 3 C20 flat roofed dormers. End stack to left. Interior: Rectangular open-well staircase with turned balusters from 1st to 2nd floor. Subsidiary features: C19 cross-wing to left. Re-set dated brick, 1788, to right of central door."

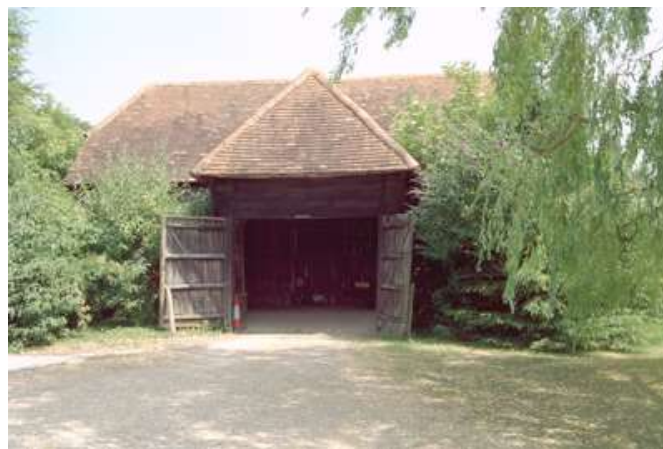
"Barn approx 40 metres east of Row Lane Farmhouse GV II Barn. Probably early C18. Early C18 red brick basal timber frame, large framing; weatherboarding; plain tile half-hipped roof. Midstrey with plank doors to west. Interior: Queen post roof construction, most common rafters replaced."

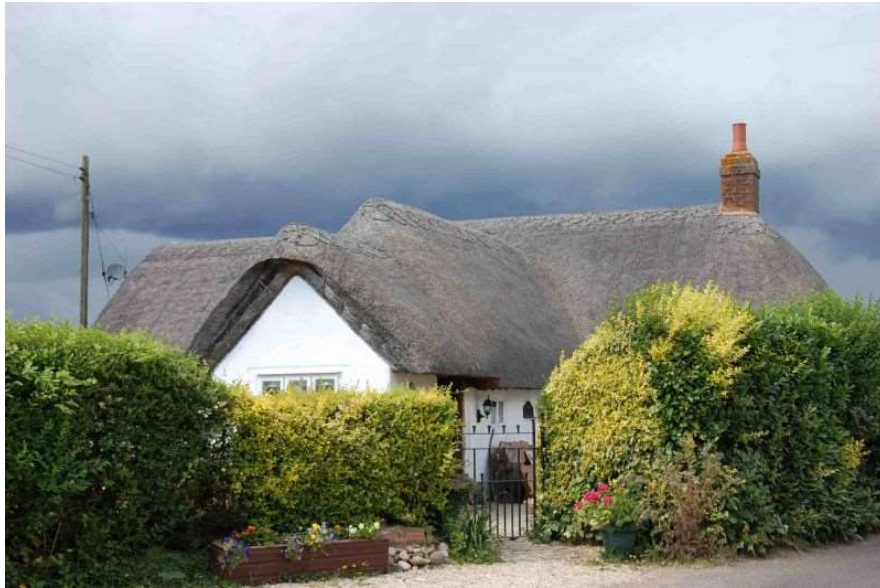
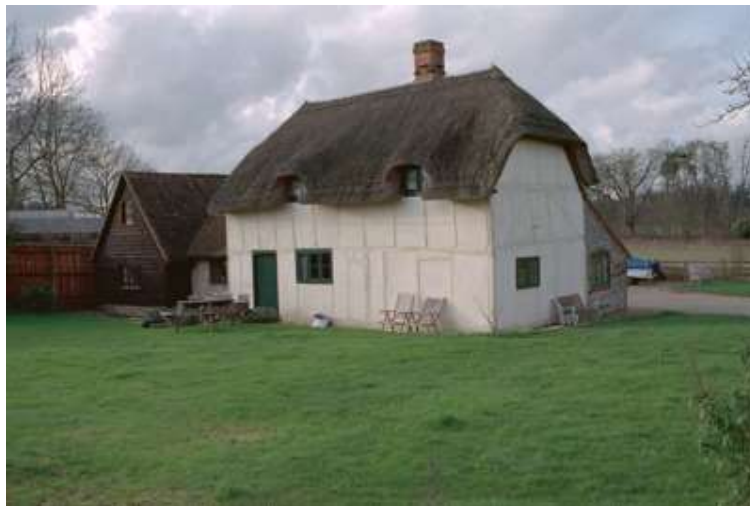
"Cottage. C16 or early C17 with later-C17 and C18 or C19 additions and alterations; further additions and alterations C20. Timber-framed with painted infill; painted brick additions; and weatherboarded side-outshut. Thatched roofs; brick stack.

One storey. Originally a single cell with half-bay smoke-bay at north-east end; chimney inserted in smoke-bay and bay added to south-west end. Subsequently, outshut built around chimney and wing added at rear. Further south-western addition C20. North-west (garden) elevation: plinth. Exposed timber-framing includes wall-posts; small-scantling midrail; intermediate posts; and wall-plate. Windows: of three lights to left of centre; two of two-lights at centre; one small light on right; and of two lights to extension. At left end: ridge stack; and cat-slide roof over outshut, which has some old weatherboard and strap-hinged door of two wide planks. Within outshut is the back of the bread-oven and house wall of flint and brick.

Rear: right-hand bay has inserted door and small two-light window. Projecting wing, of two builds, on east side has door on left and two small two-light windows, that on right with shutter stanchions and two-pane lights; exposed rafter feet. Three windows to section on left.

Interior: exposed timbers and beams. Large brick fireplace with timber bressumer and bread-oven. Blackened roof timbers survive over the earliest, left-hand, section, including crude rafters with scribed carpenters' marks, a queen-post roof truss, and clasped

purlins. Unsooted wattle and daub survives in apex of truss between earliest section and addition.”

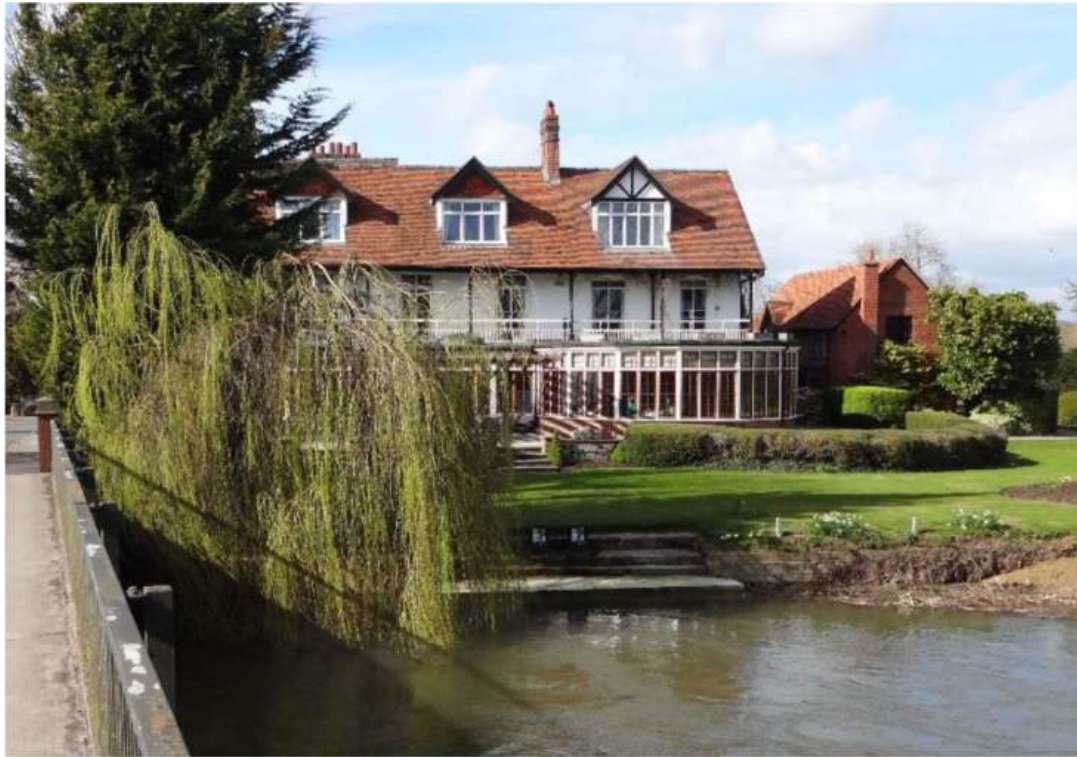
Site of the original Horn pub, commands very significant views over backwater of the Thames which has important amenity value. Set of adjacent houses which make significant contribution to character of Conservation Area

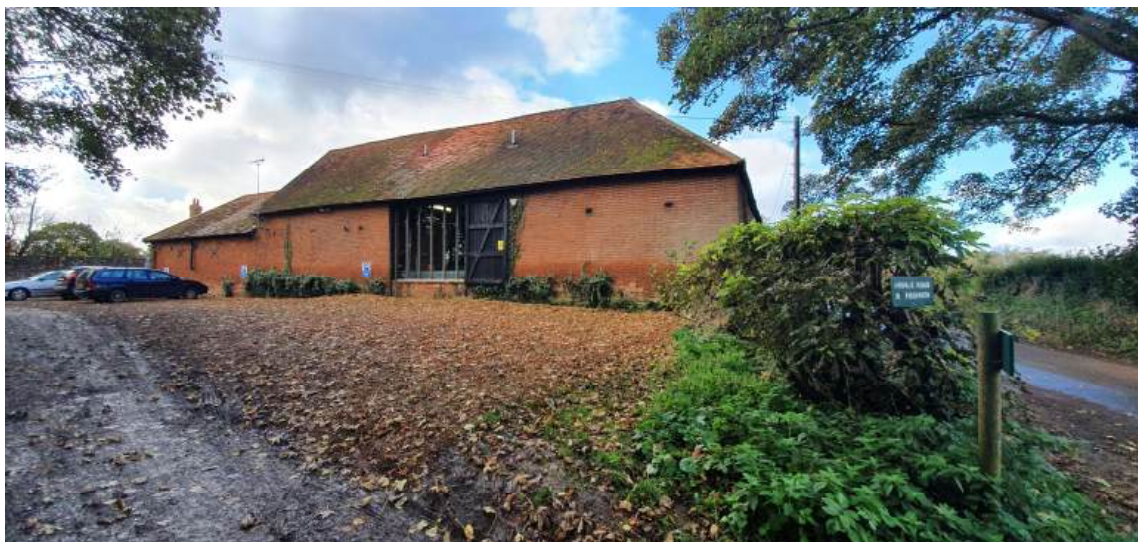
Brewery that runs from a 18th century converted brick and flint barn that was previously associated with Dunsden Green Farmhouse and was used for the storage of grain. The building was separated from the Farmhouse in 2002 and is located at a focal point for the village when entering from the west.

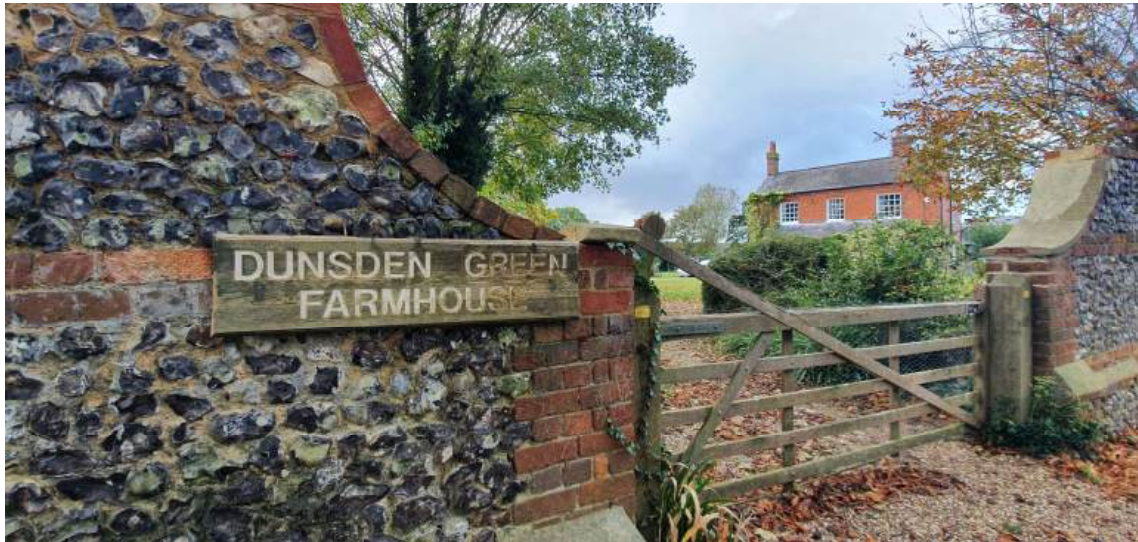
Attractive Victorian villa-style property with impressive flint-faced garden wall alongside public footpath.
