Appendix 12.0 Pedestrian Links Survey

General Footway Review

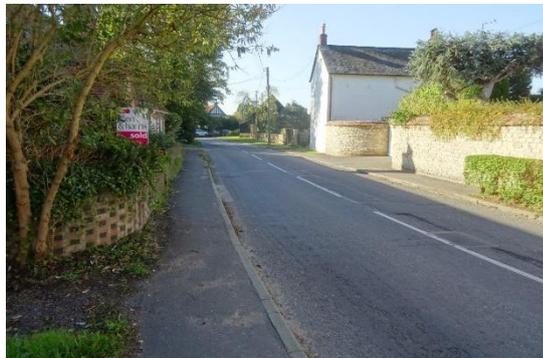
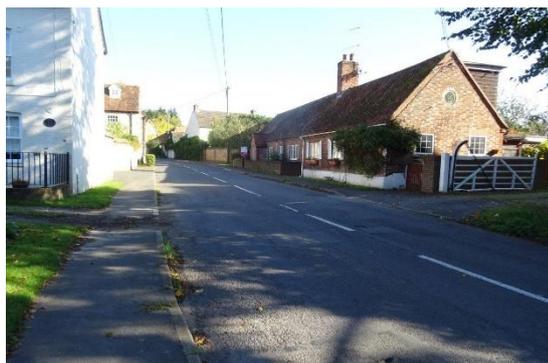
Road Crossing 1:

Traffic Road crossing point on the A329 (opposite 70 Thame Road, below photos) is on a dangerous corner. This is used to access countryside walks and the village hub from the north of the village.

Two dangerous pedestrian crossings (1 & 2, right) are described below. Proposals to resolve these are anticipated from the traffic survey commissioned by the Parish Council.

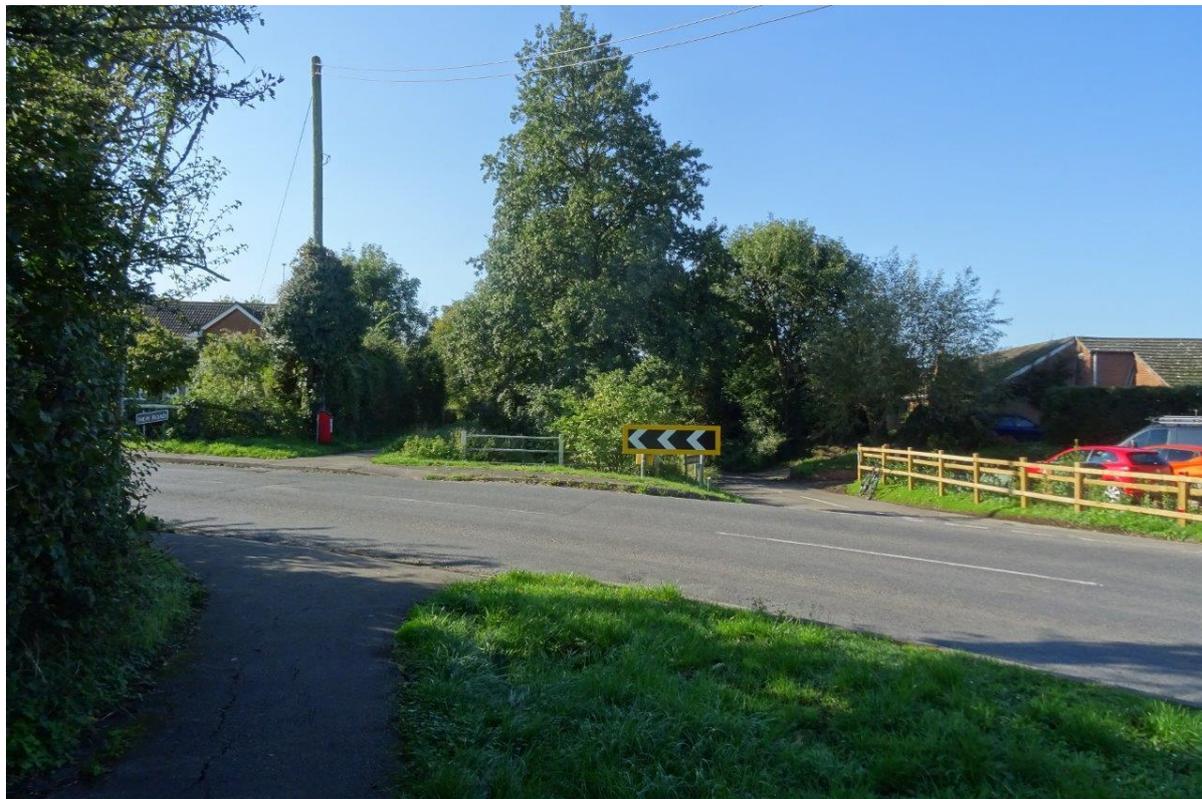
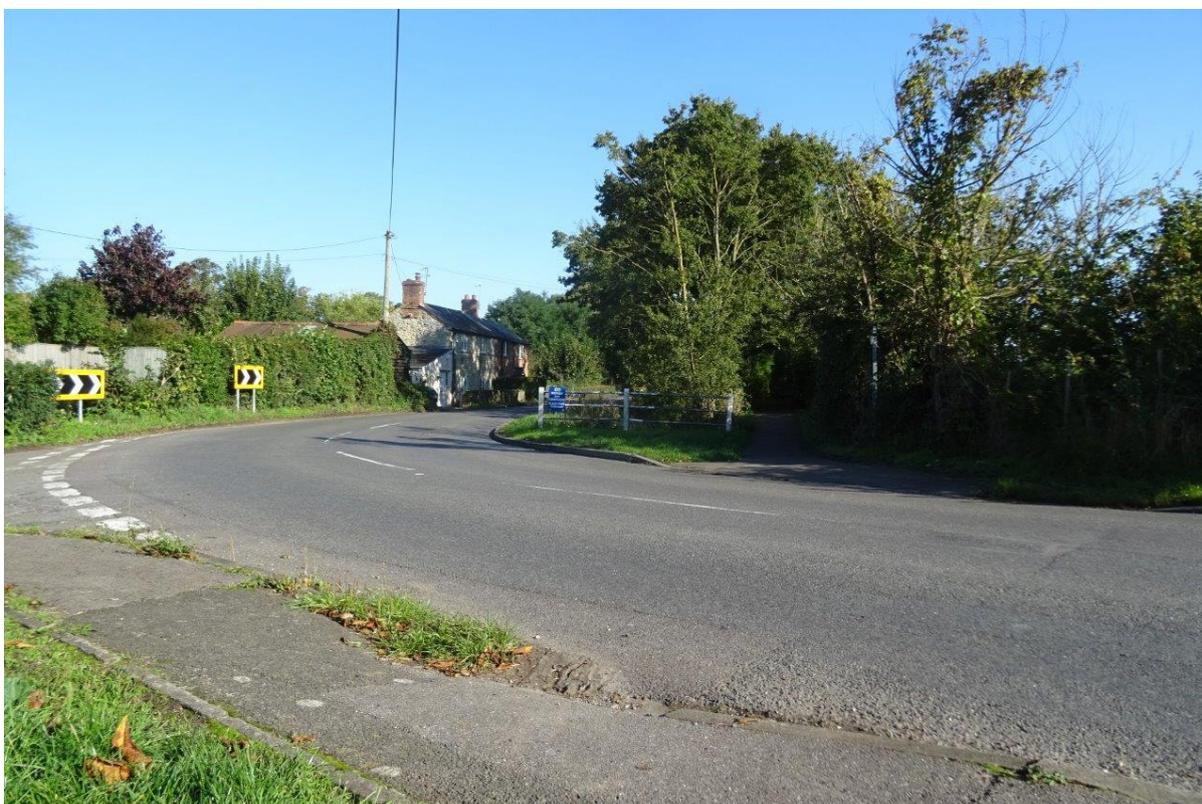
Road Crossing 2: The road crossing point as New Road becomes Thame Road

This crossing point (photographs below) has three issues.

- Issue 1: This is a very sharp corner with fast moving cars so visibility is key but extremely poor.
- Issue 2: Dense vegetation at the edge of Thame Road hampers visibility of oncoming traffic.
- Issue 3: For wheelchair and pushchair access the dropped curve is very narrow and is at a dangerous angle.

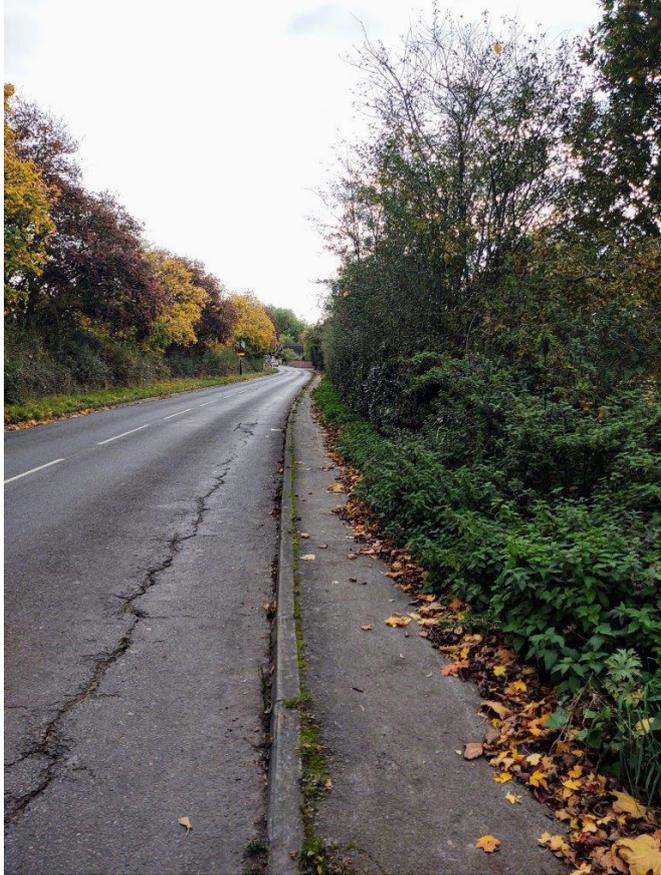
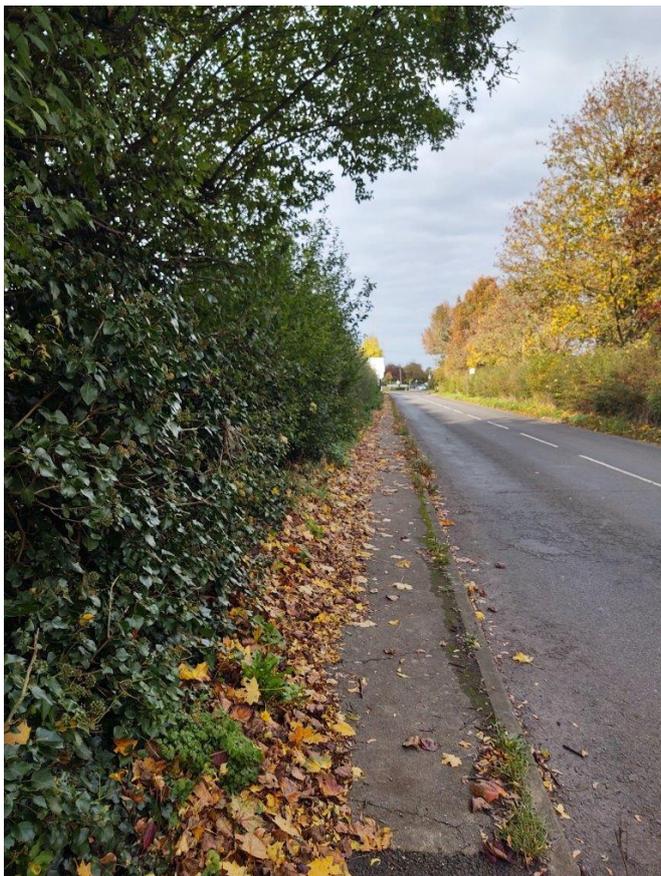
Wallingford Road Shillingford

The pedestrian footpath between the A4074 roundabout and Shillingford Bridge is very narrow and poorly maintained. Even walking in single file places you dangerously close to on-coming traffic.

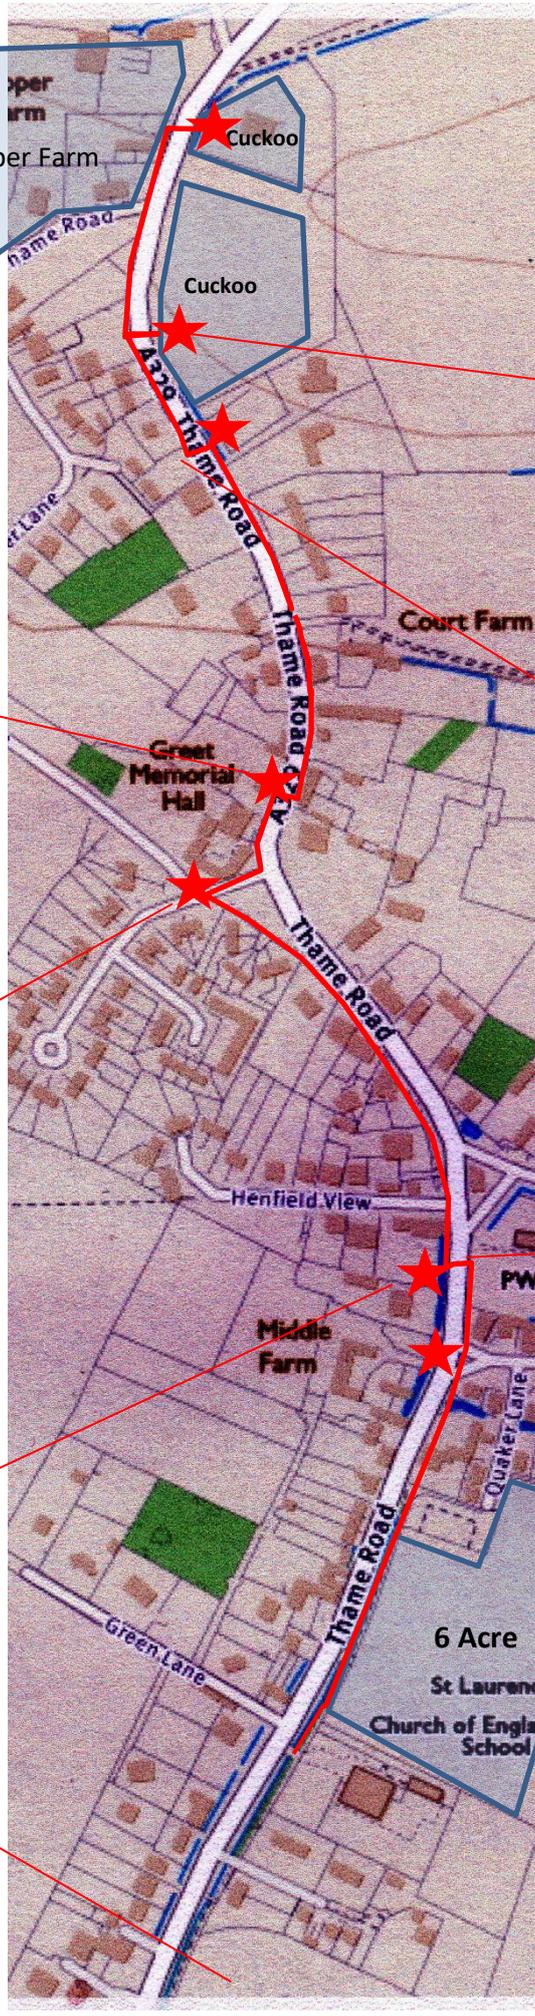
Footway Review

The footways serving the sites included in the Technical Site Assessment were surveyed. Key findings are shown in the annotated map, over, and are supplied for supplementary evidence.

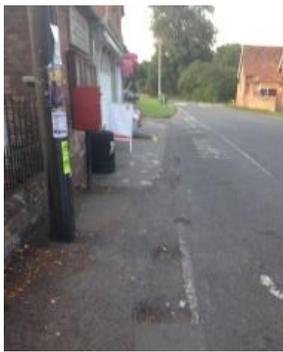
Upper Farm Entrance

no raised footway

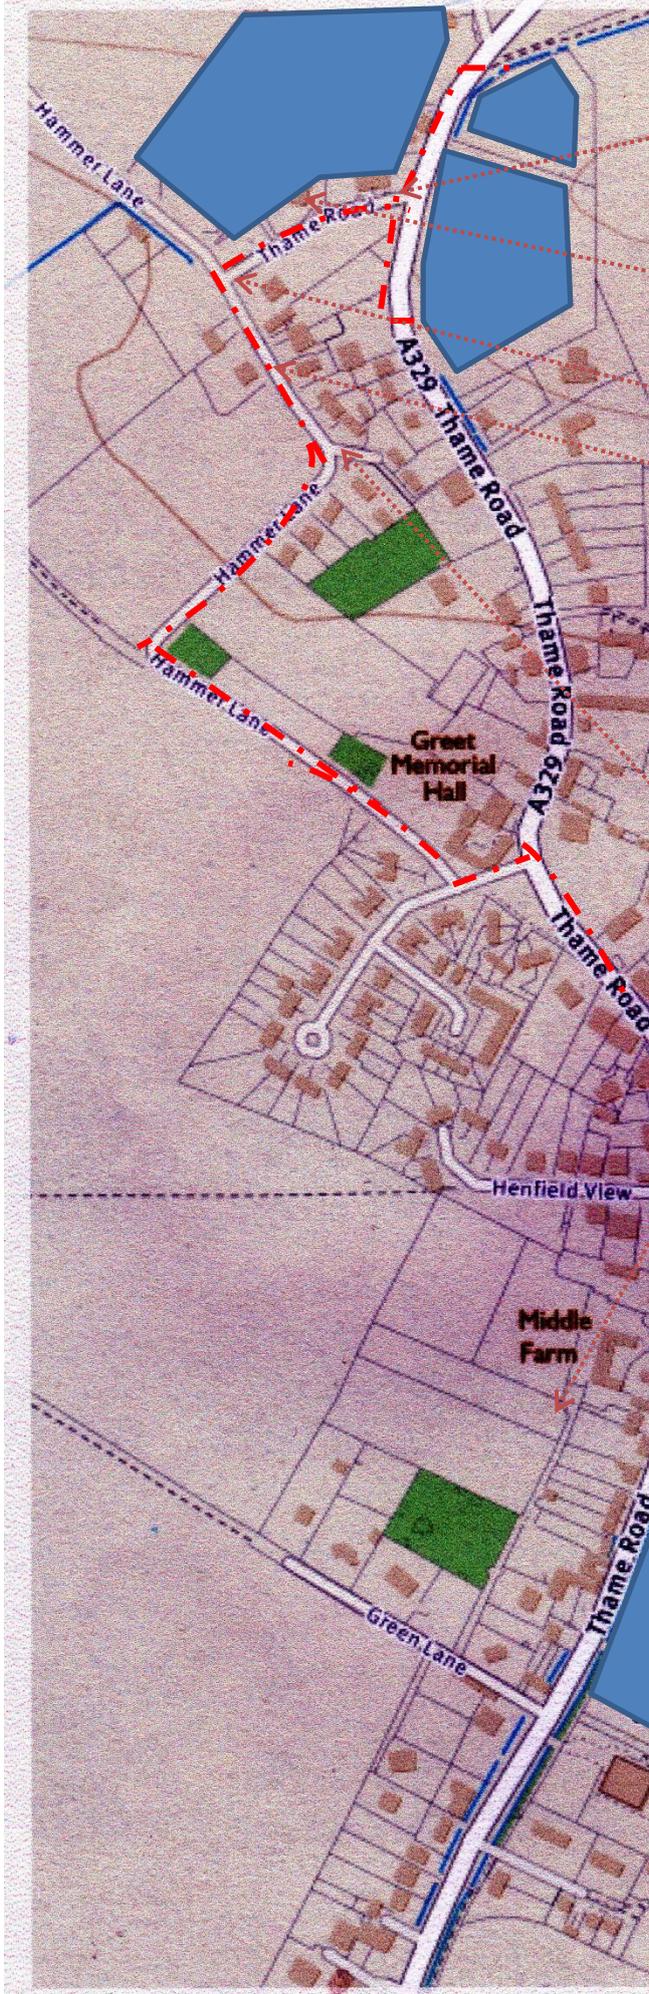
Archive Historical 2018 Neighbourhood Plan Site Assessment: Footway mitigation route

A suggestion to use this route as an alternative to Thames Road footways was suggested by a Land Owner of a potential northern-end housing site. Findings are highlighted below:

The section of this running from Thame Road to Hammer Lane is private track and should not be marked as Thame Road.

Hammer Lane itself is single track lane with public access, but with no footpath and is unadopted from Violets Farm

Potholes and uneven surfaces on this track with no dedicated footway

Alternative cut through narrow track with rough surface is unsuitable for pushchairs
